Damage Observations and Issues Related to Building Performance

Building Survey Team of
JSCE-AIJ Joint Reconnaissance Team

QUICK REPORT OF
DAMAGE INVESTIGATION ON BUILDINGS AND HOUSES
DUE TO OCTOBER 8, 2005 PAKISTAN EARTHQUAKE

November 26, 2005

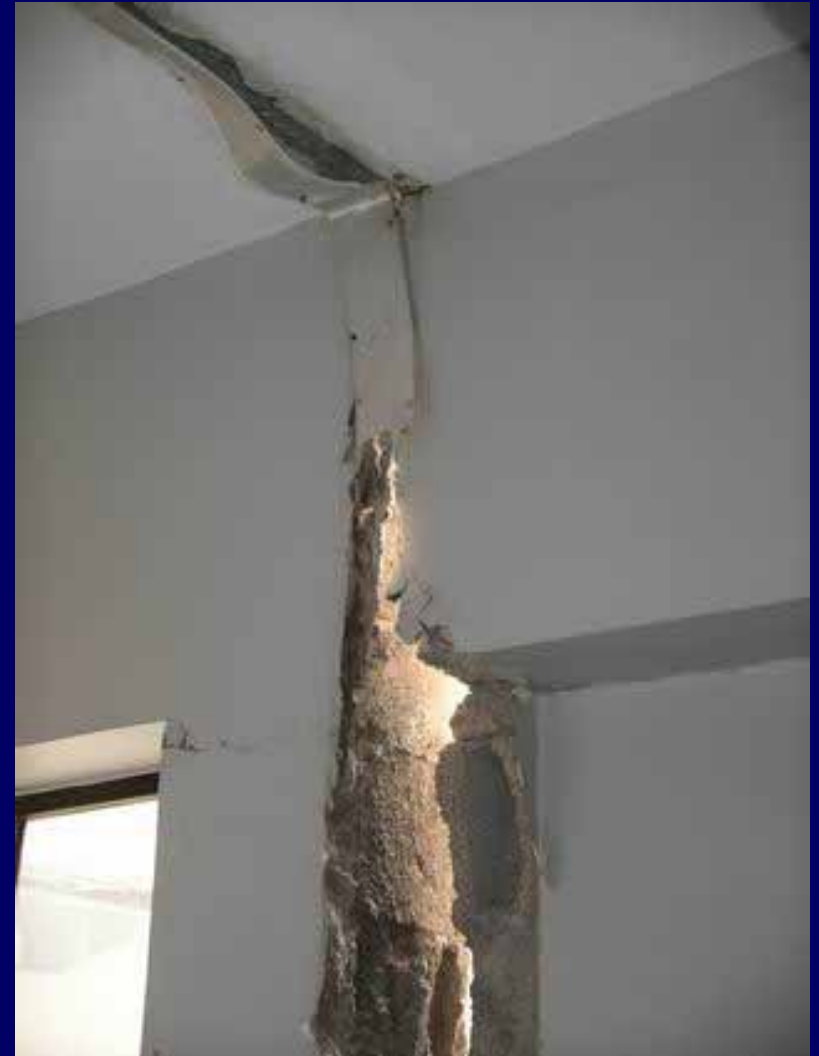
- ◆ Extensive Damage to URM Walls
- ◆ Damage to Expansion Joints
- ◆ However, No Major Damage to Structural Members

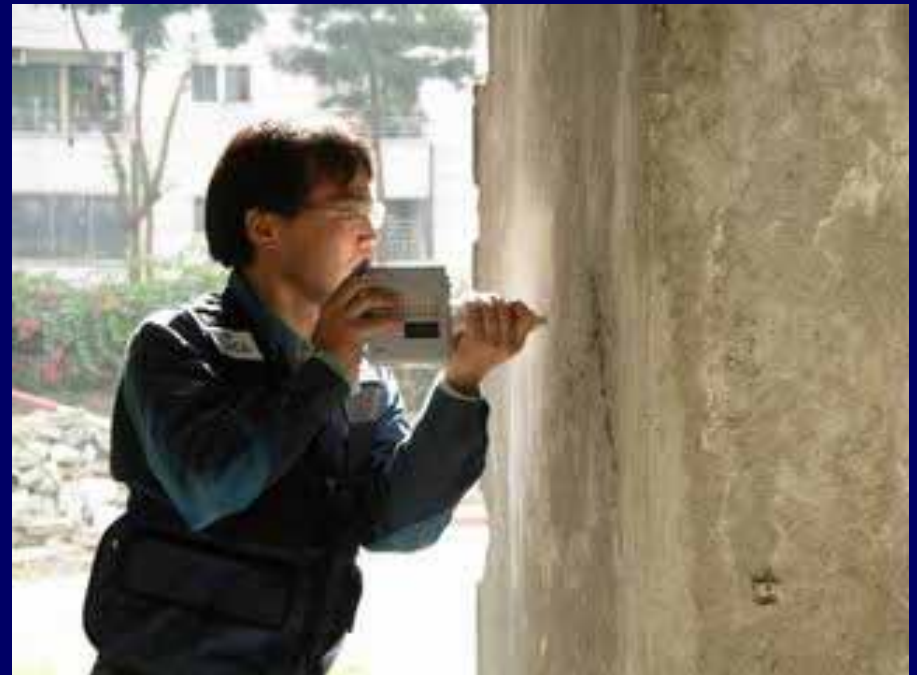
- ◆ Schmidt Hammer Tests in Building Nos. 2 - 4
 - Non-destructive test to estimate concrete strength from hardness of concrete surface.
 - It is often referred to estimate concrete strength especially when destructive tests are difficult to perform.

- ◆ Test results
 - 12 N/mm² (No. 2)
 - 17 N/mm² (No. 3)
 - 15 N/mm² (No. 4: collapsed)
 - ➔ Generally lower than requirements for Japanese high-rise buildings

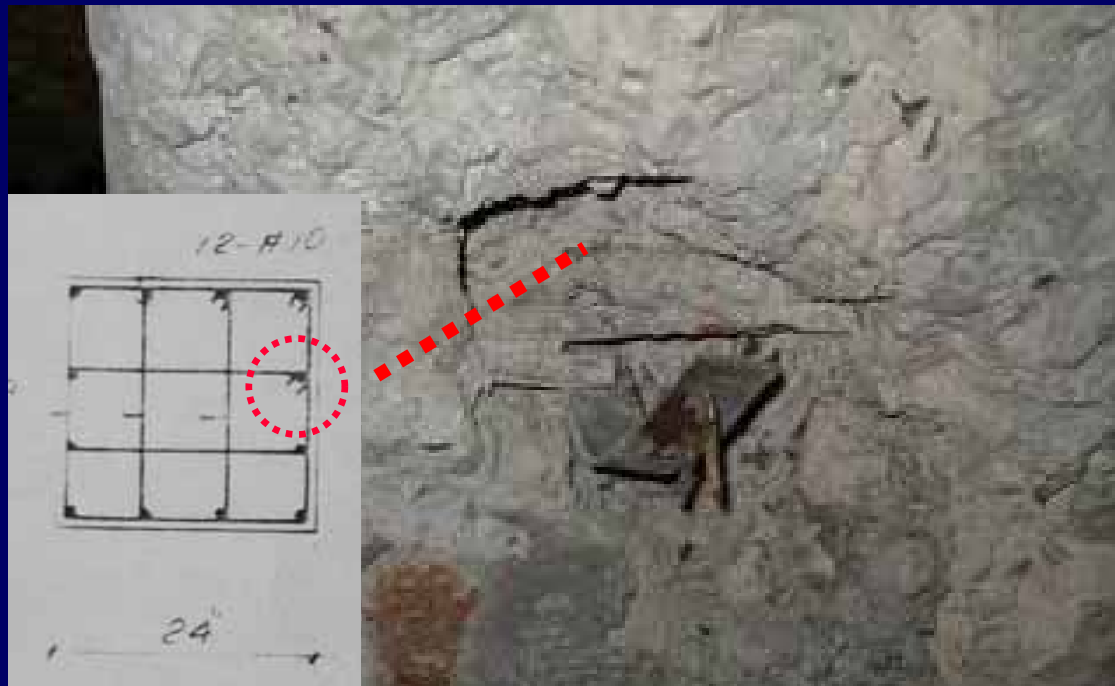
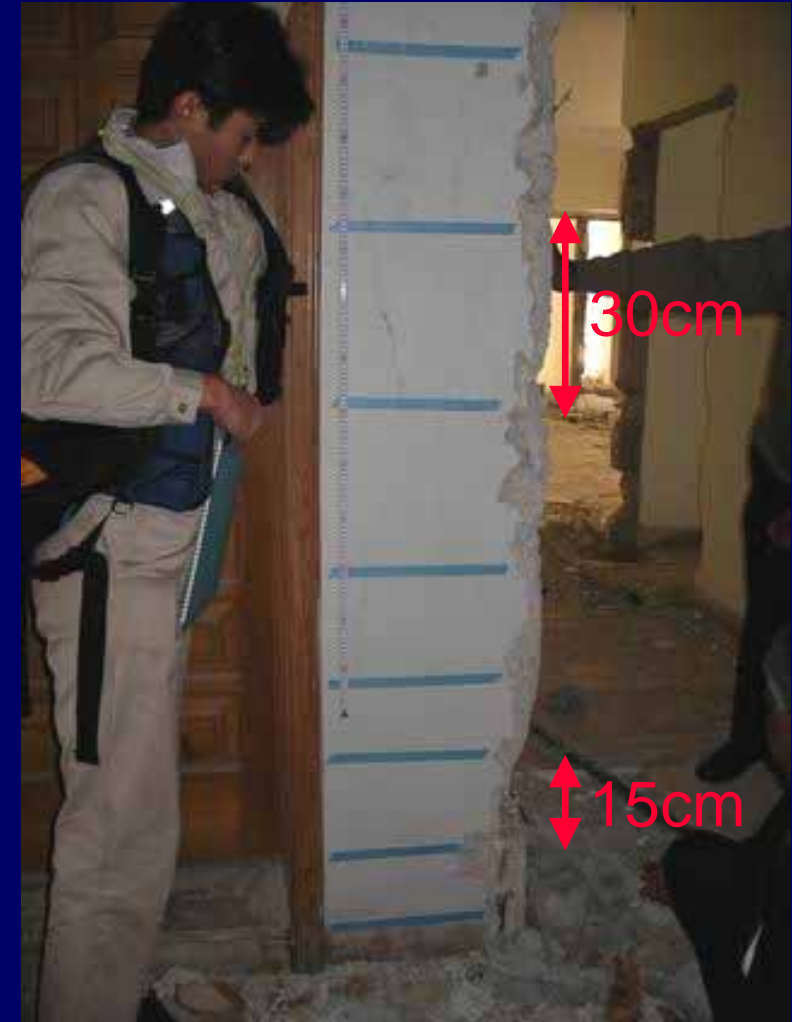
- ◆ Reinforcement Detections
 - 90-degree hooks although 135-degree specified in structural drawings

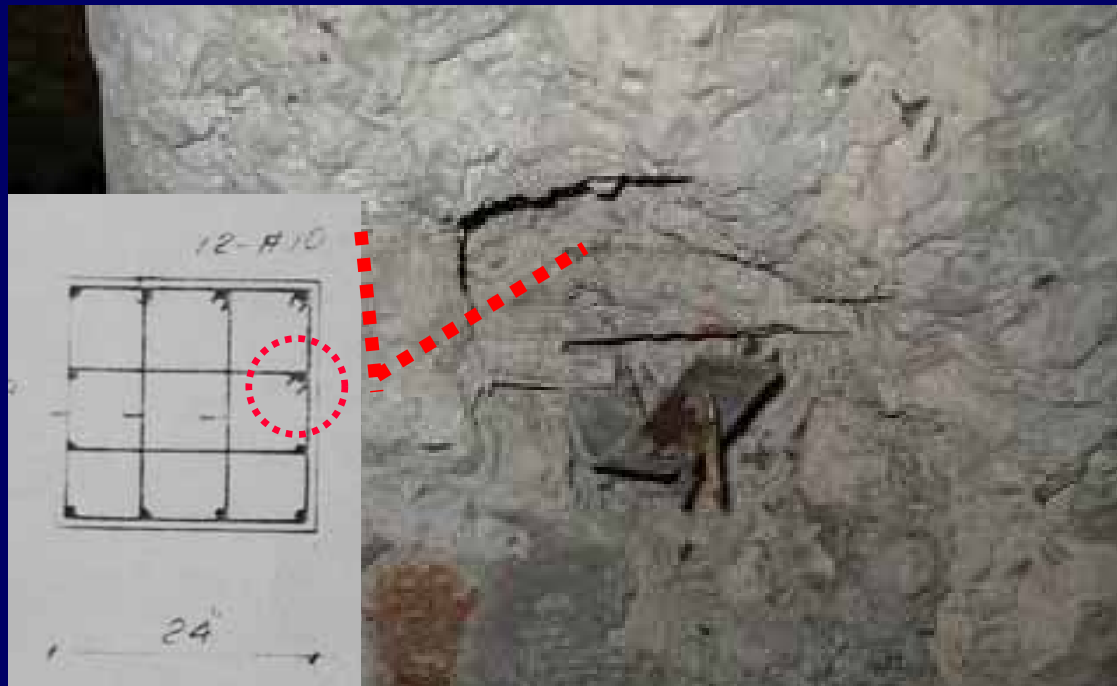
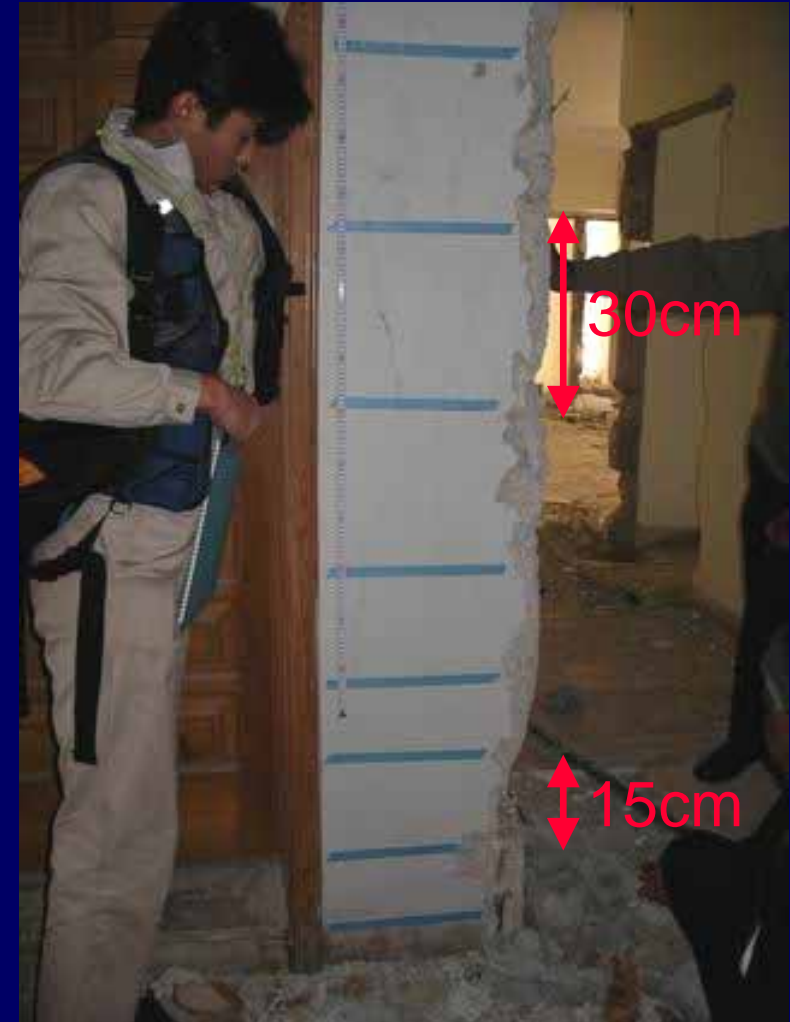
- ◆ Reinforcement Detections
 - 90-degree hooks although 135-degree specified in structural drawings

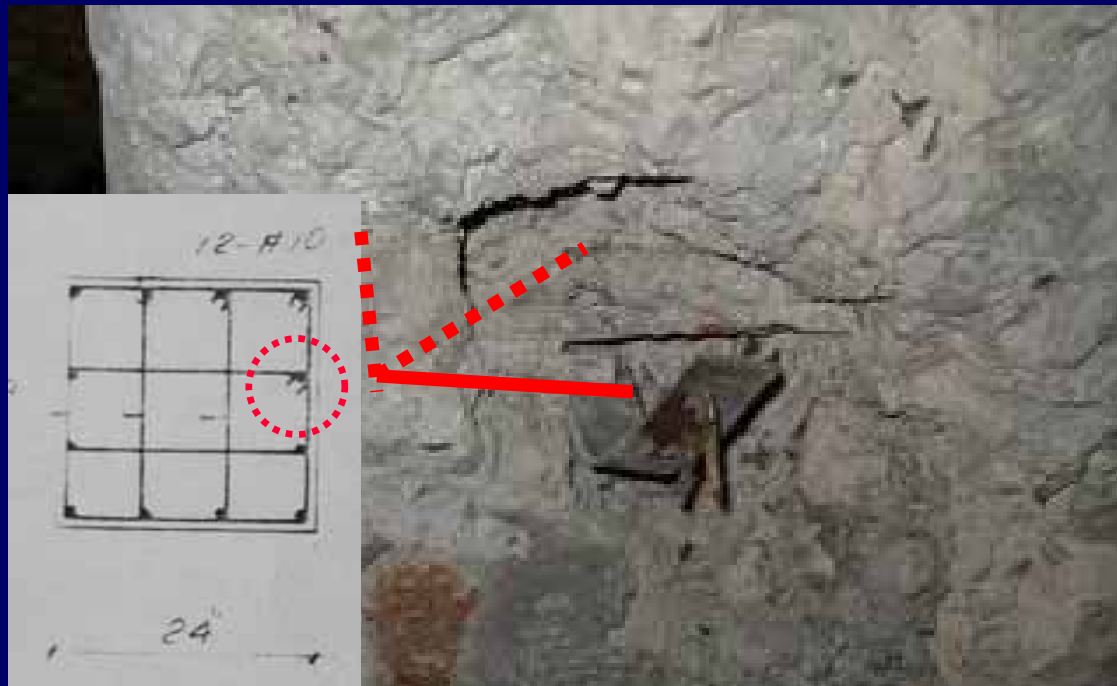
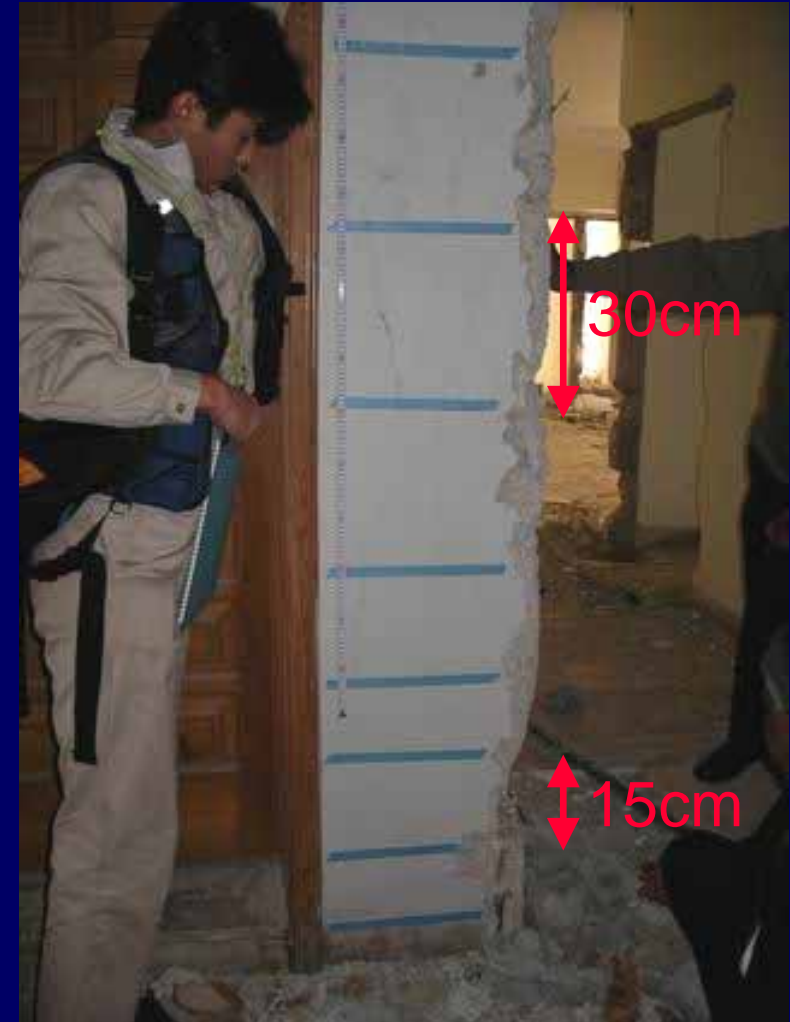
- ◆ Reinforcement Detections
 - 90-degree hooks although 135-degree specified in structural drawings

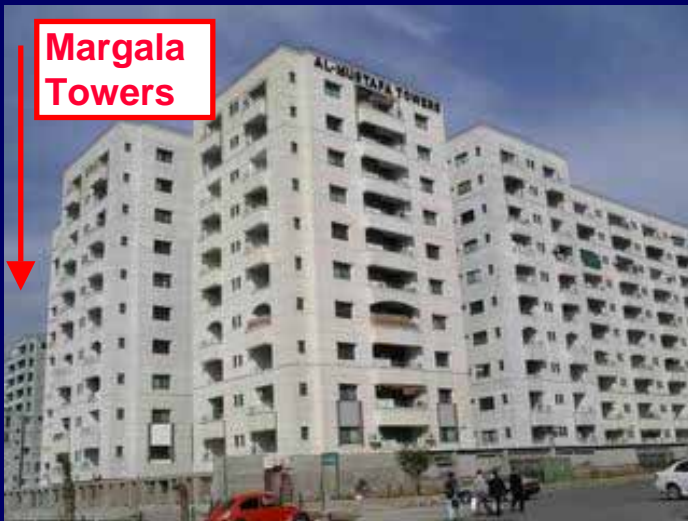
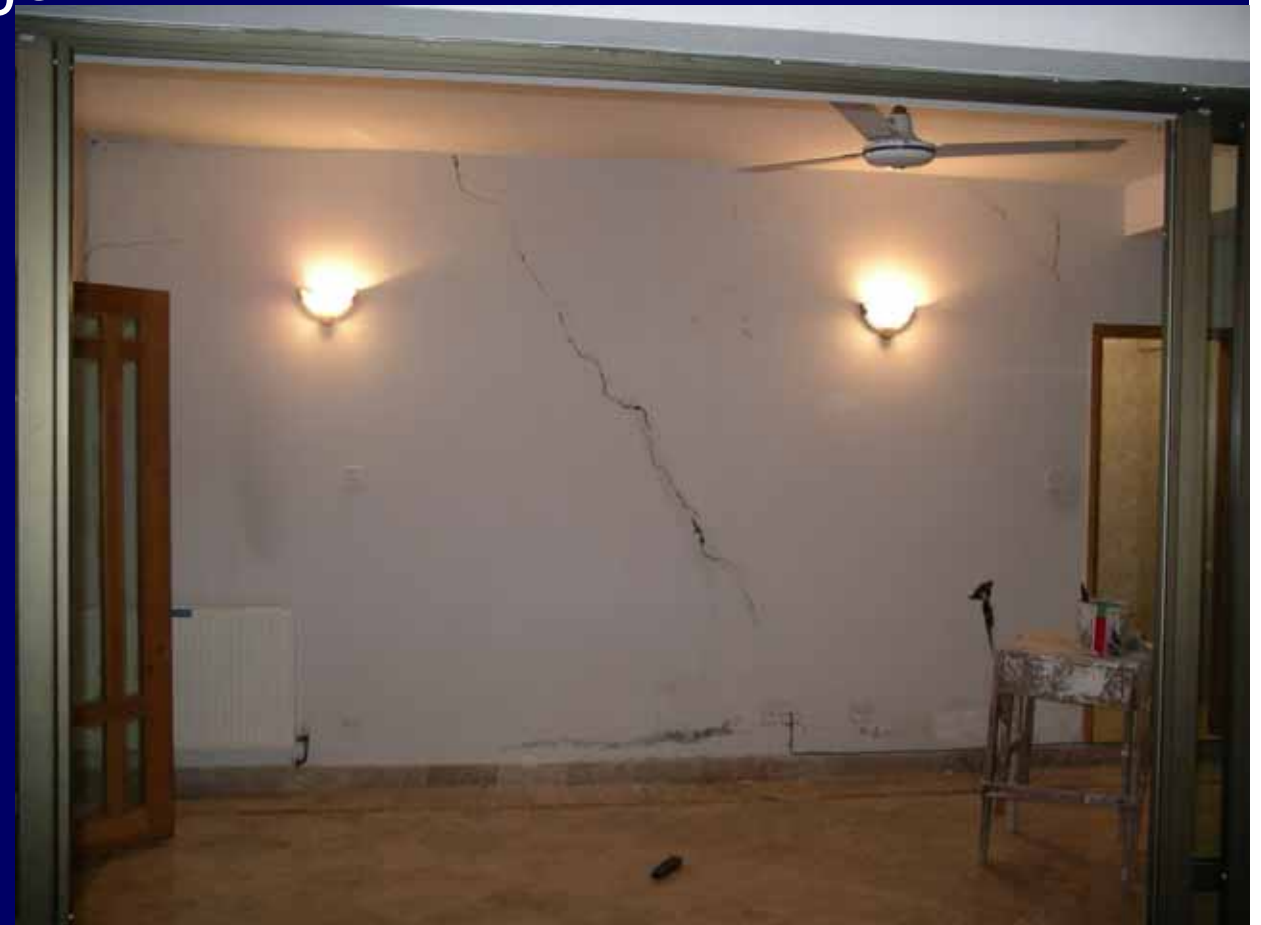
- ◆ Cracks in URM Walls
- ◆ No Visible Damage to Structure
- ◆ Schmidt Hammer
 - 28 N/mm²

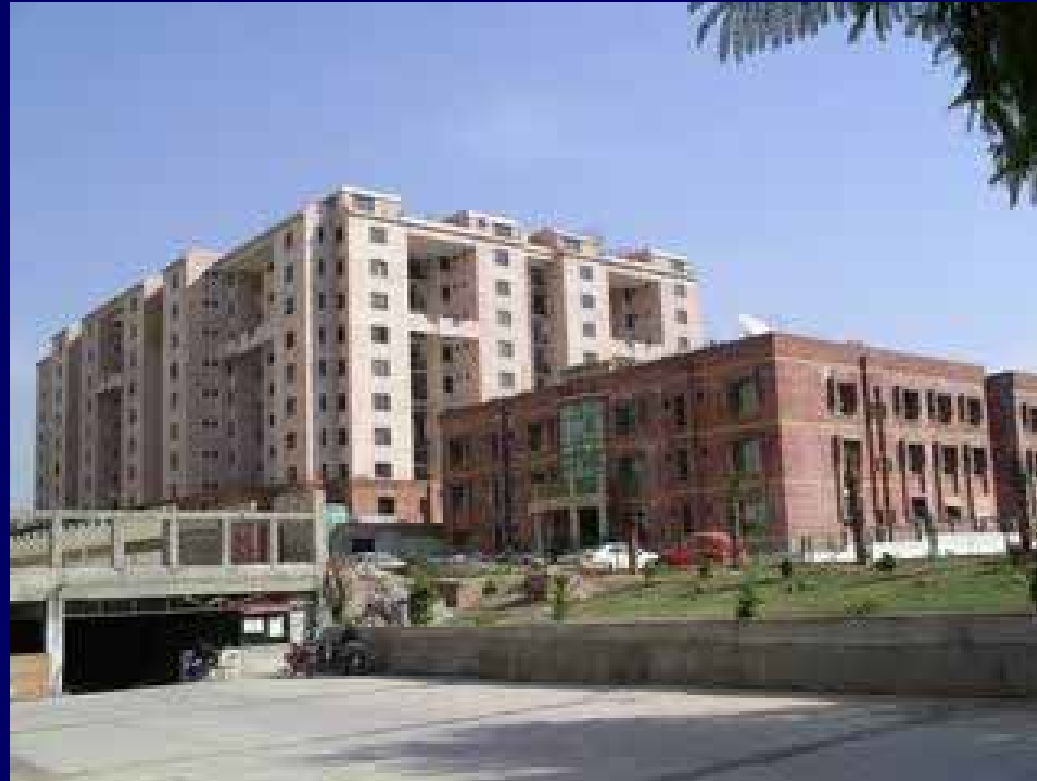
- ◆ Cracks in Beams of:
 - Basement
 - Open corridor in upper stories

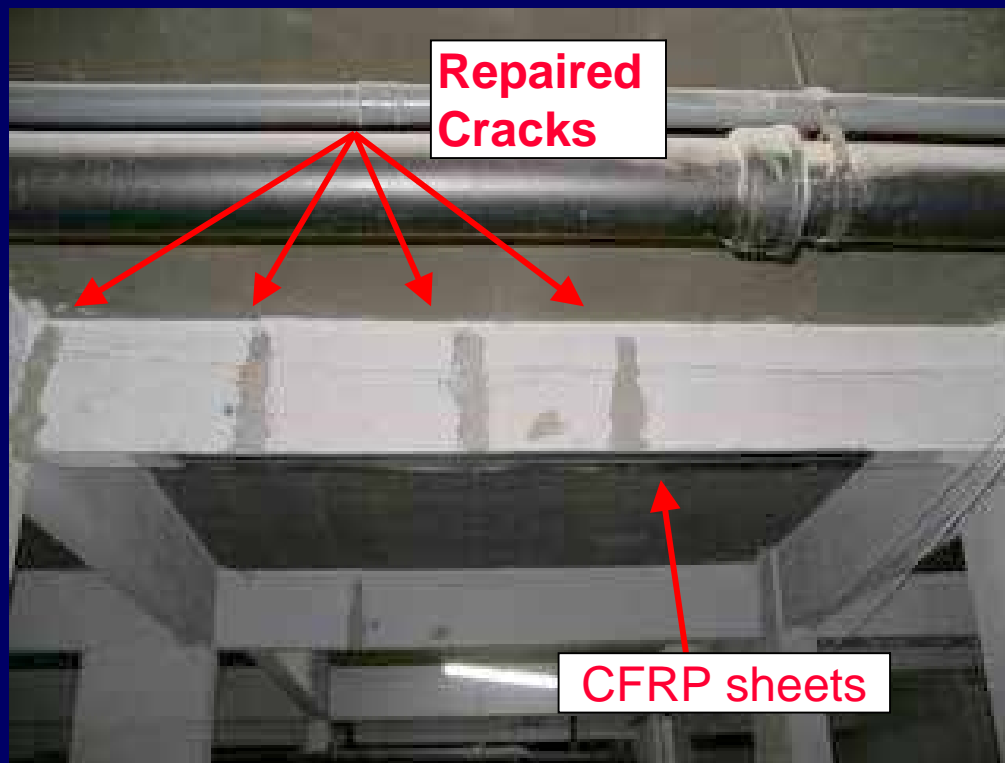
- Basement: Mid-span → Vertical Loads → Initiated before EQ
- Open corridor in upper stories EQ

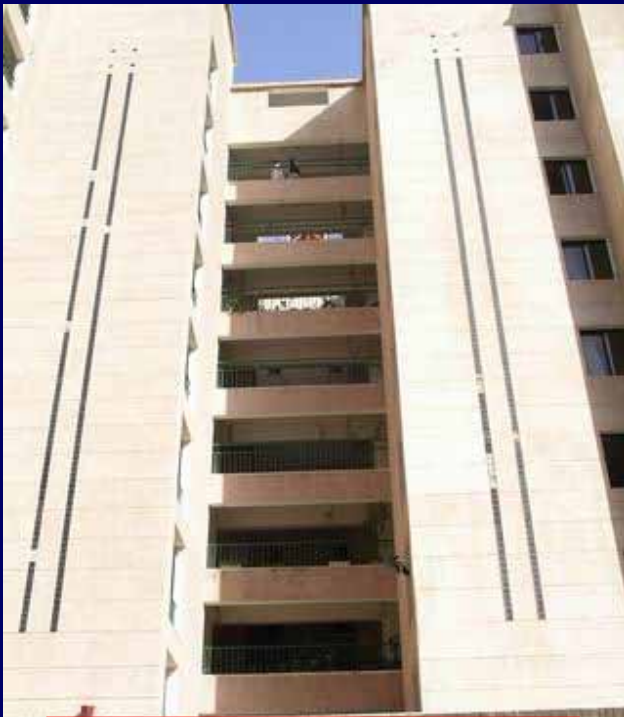
West Building

- Basement: Mid-span
- Open corridor in upper stories: Beam-ends → Caused by EQ

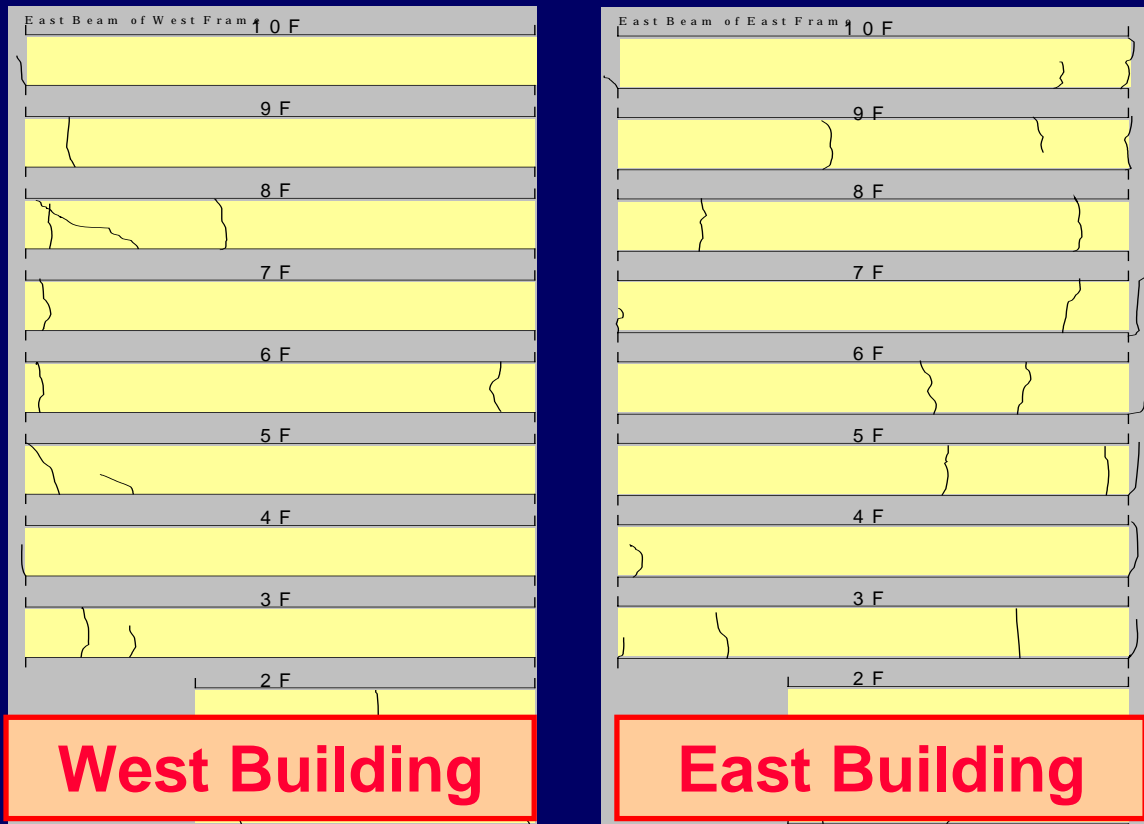
- Basement: Mid-span
- Open corridor in upper stories: Beam-ends → Caused by

- No major difference in crack patterns between two buildings
- Two buildings behaved in the same manner
- Quantitative damage surveys are essential

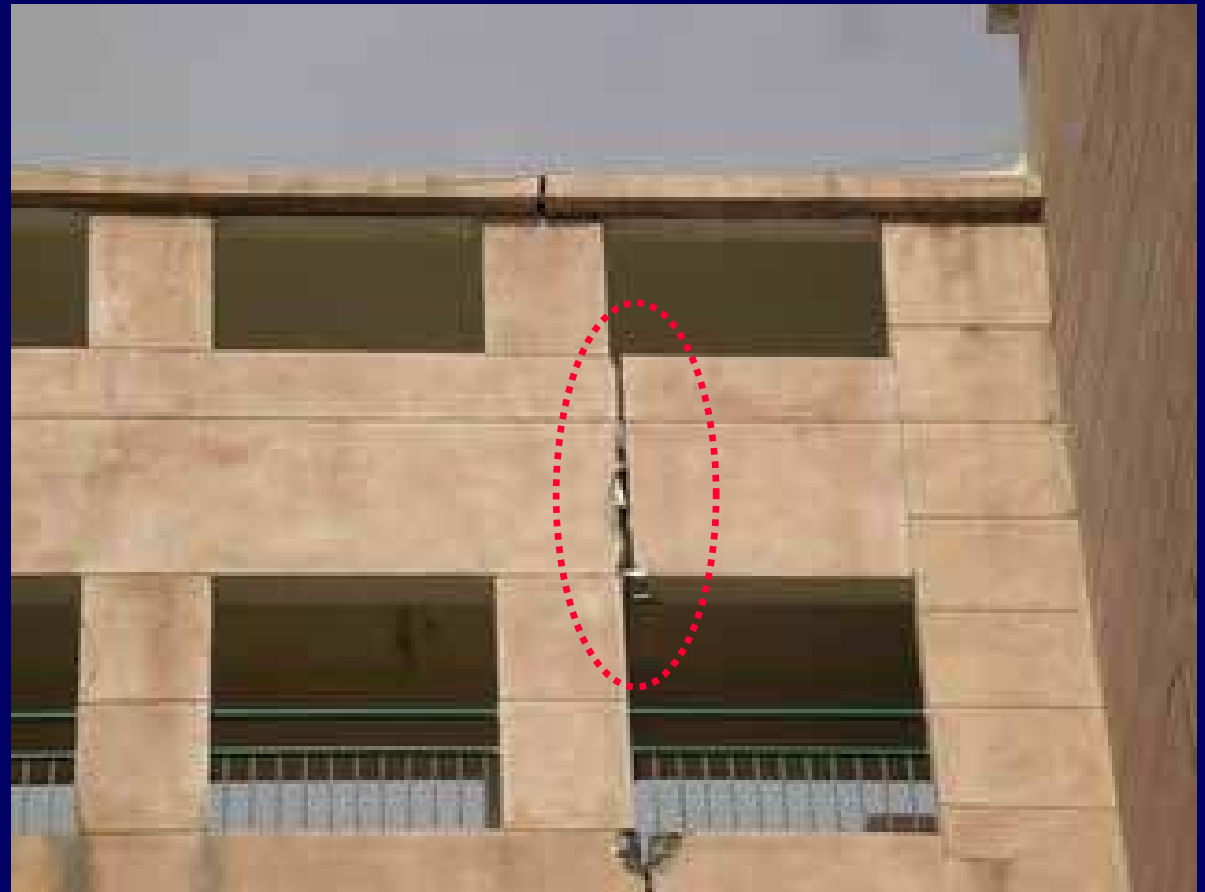
- ◆ Pounding at Expansion Joints
 - Wider gaps between adjacent buildings are recommended

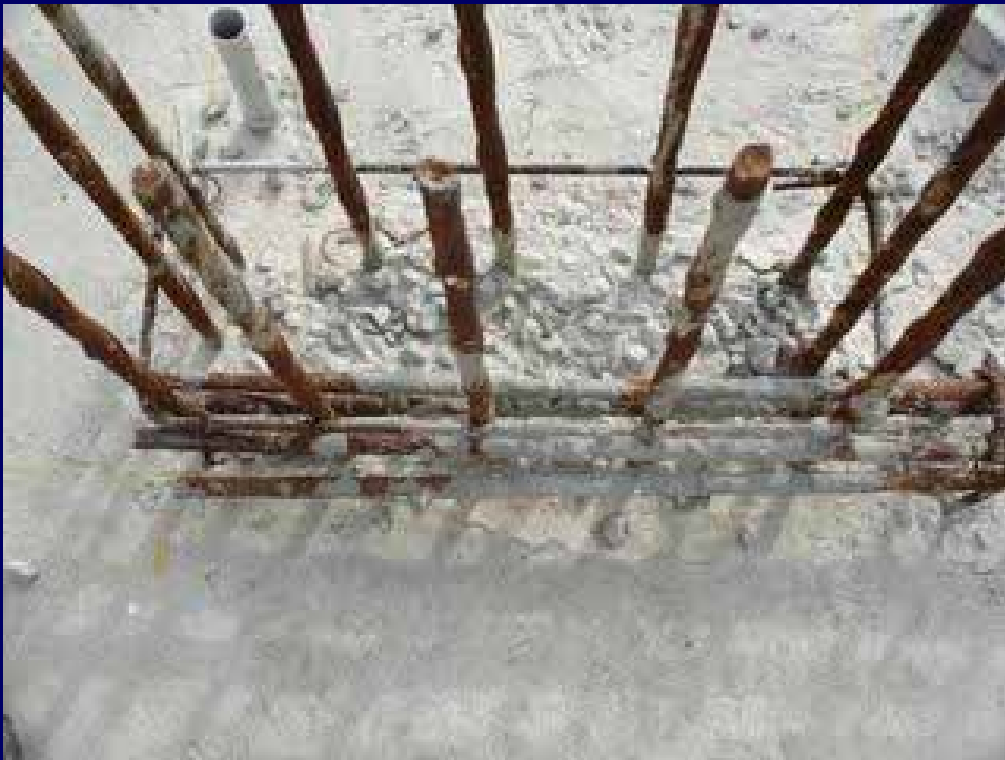
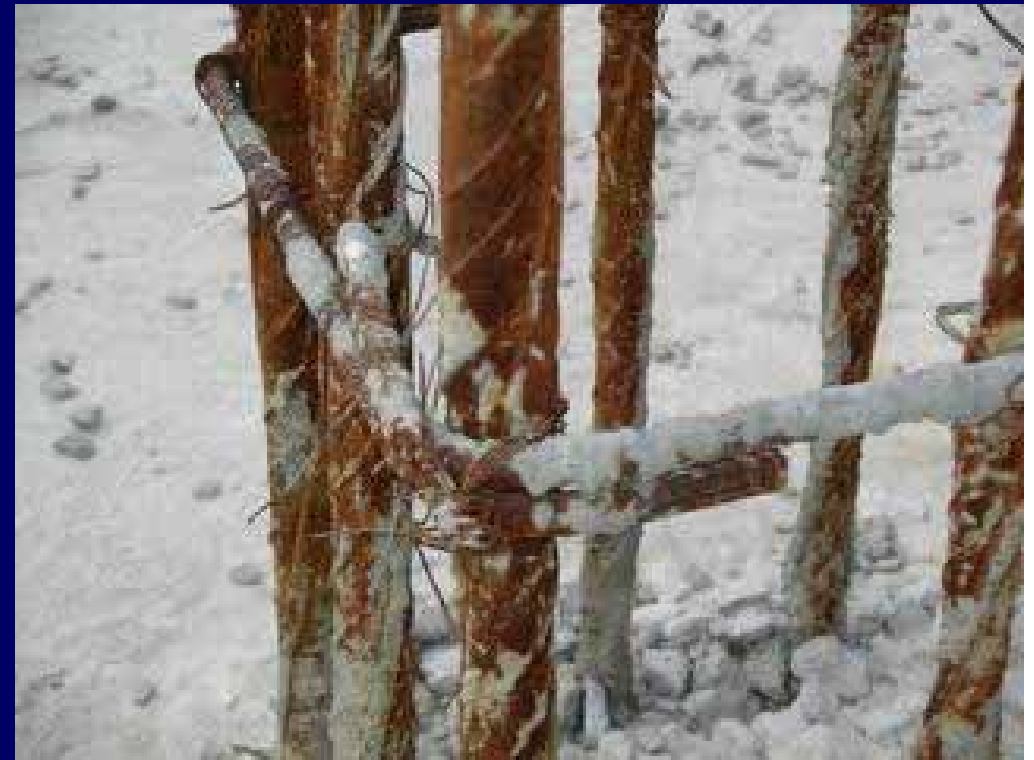
- ◆ Poor Detailing of Rebars
 - Beam rebars out of column reinforcement cage
 - 90-degree hooks of shear reinforcement

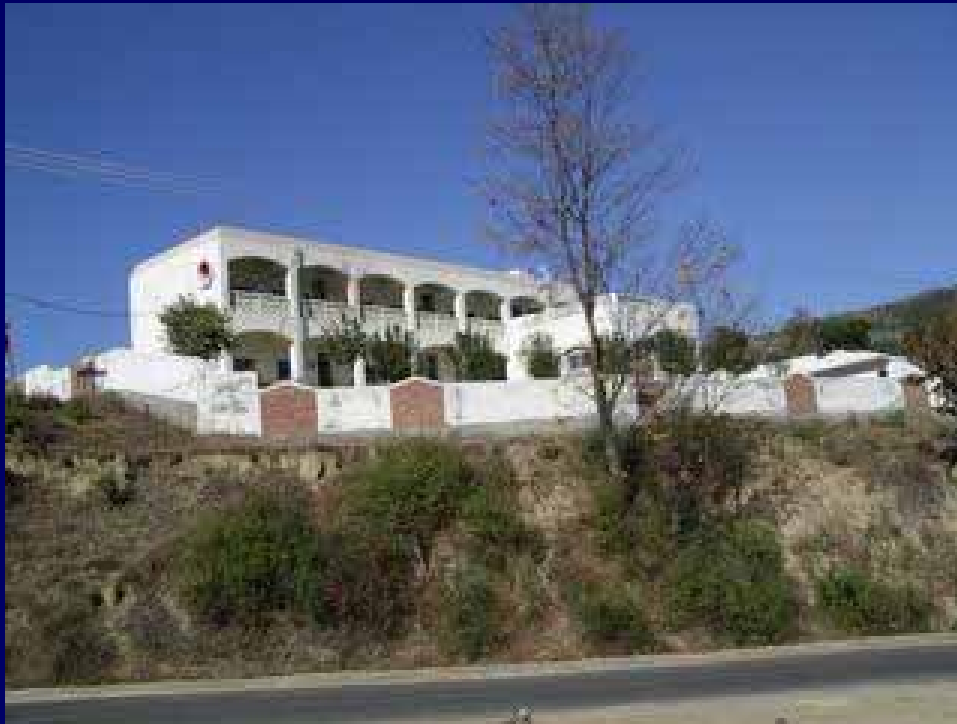
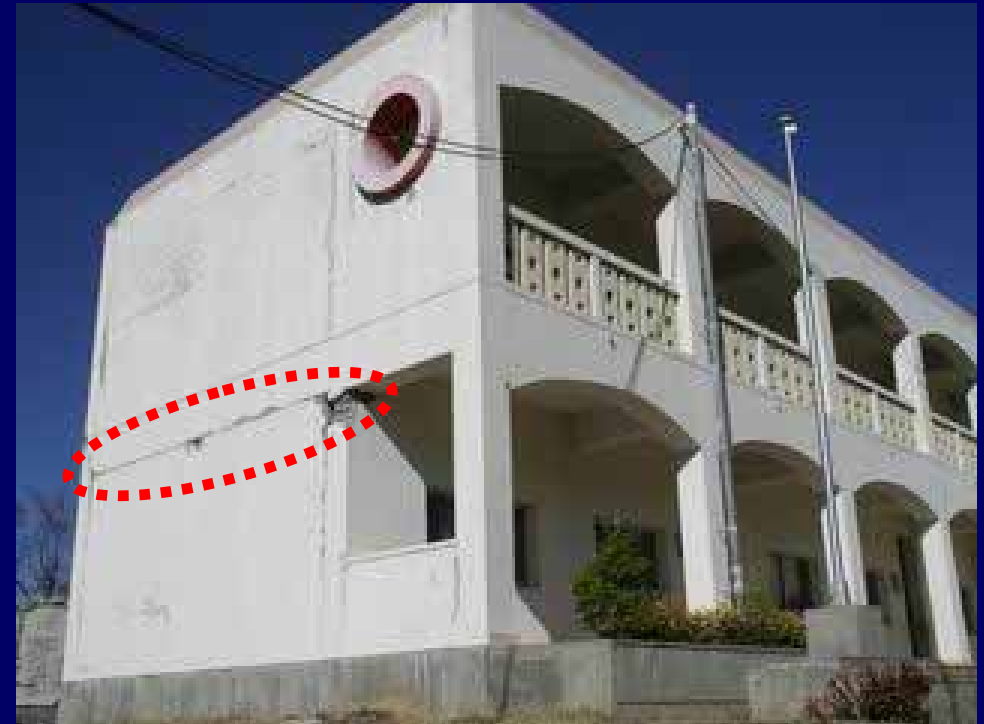
- ◆ 2-story School Designed to Japanese Building Code
 - Flexural cracks at the top of a column
 - Extensive shear cracks in an URM wall

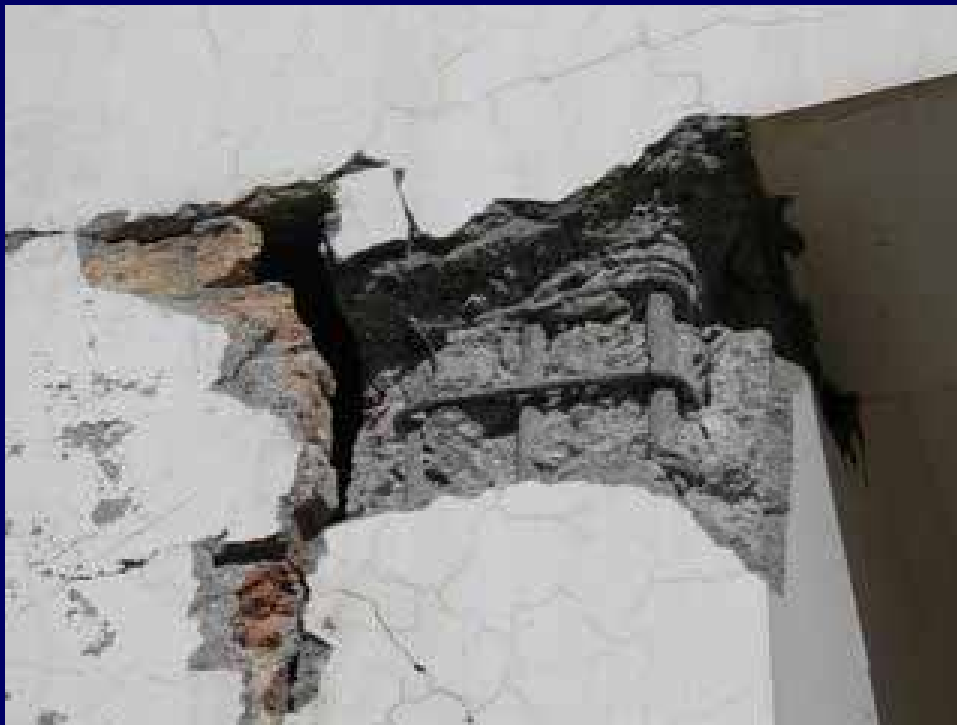
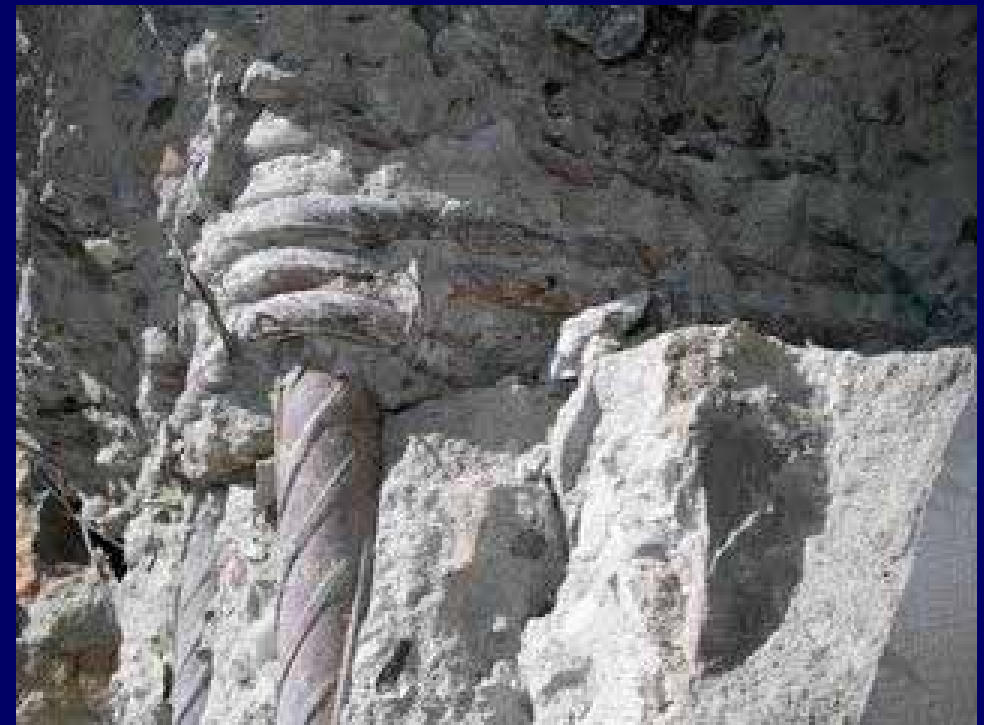
- ◆ Flexural Cracks Exposing Reinforcing Bars
 - Shear reinforcement: D10@10cm with 135-degree hooks
 - No buckling of main bars observed

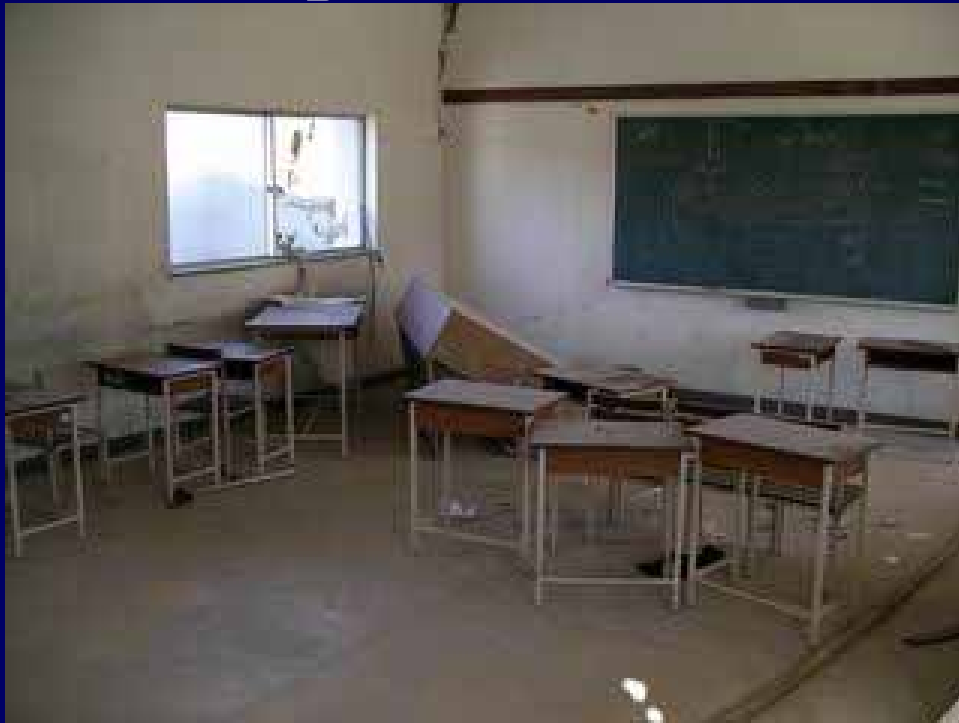
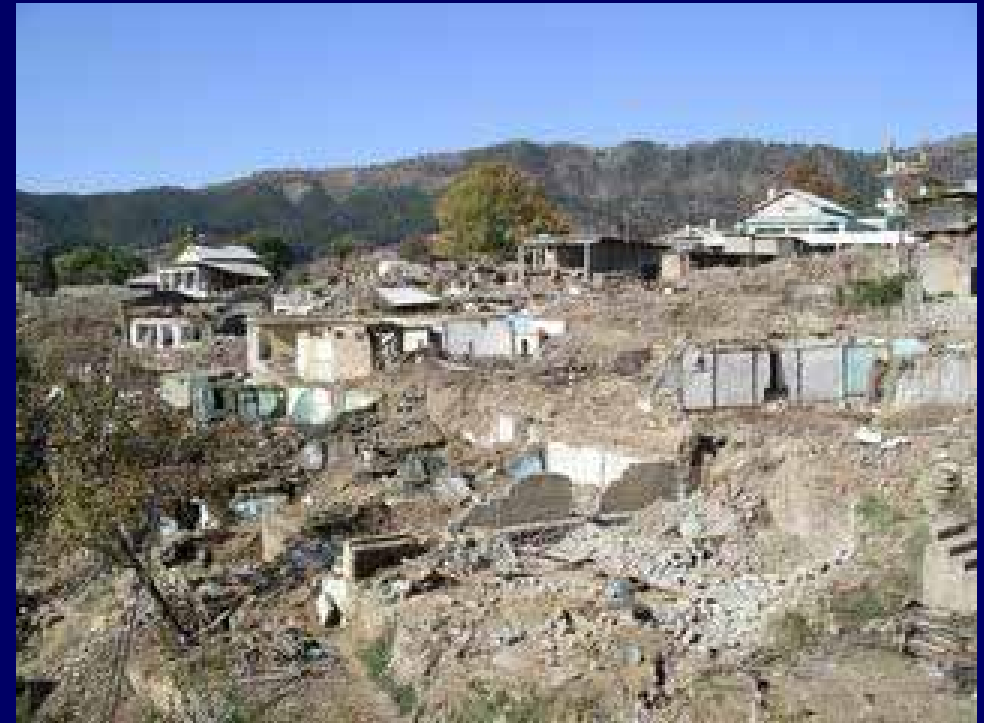
- ◆ Evidence of Strong Shaking but Survived the EQ
- ◆ Schmidt Hammer Tests: 21 N/mm²
- ◆ Seismic Capacity Evaluation: $C_B=0.48$
(C_B = Strength / Building Weight : Base Shear Coef.)

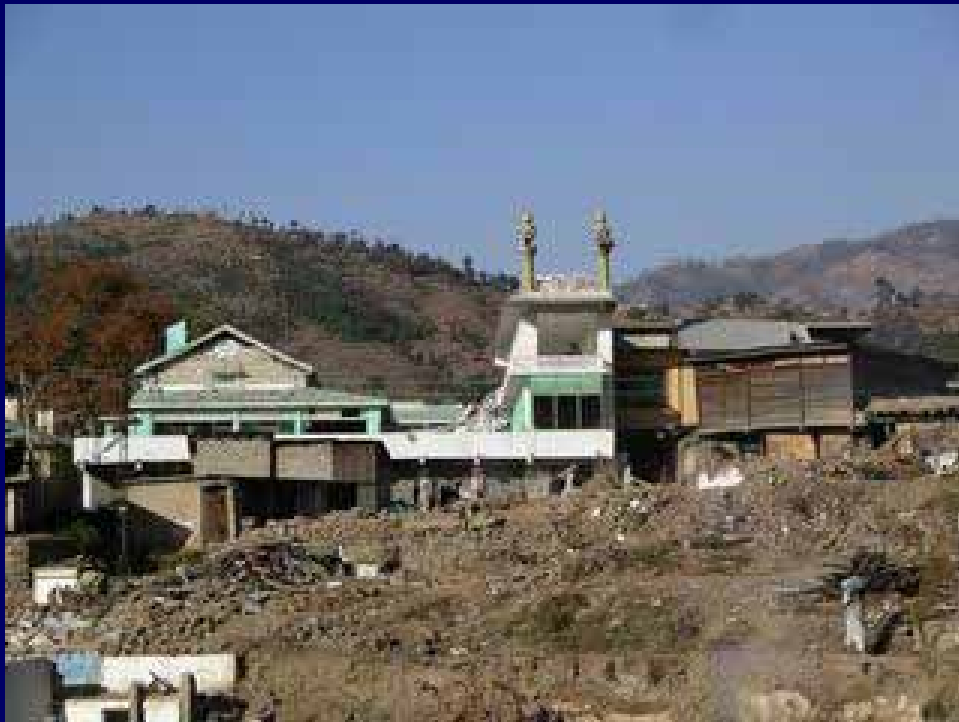
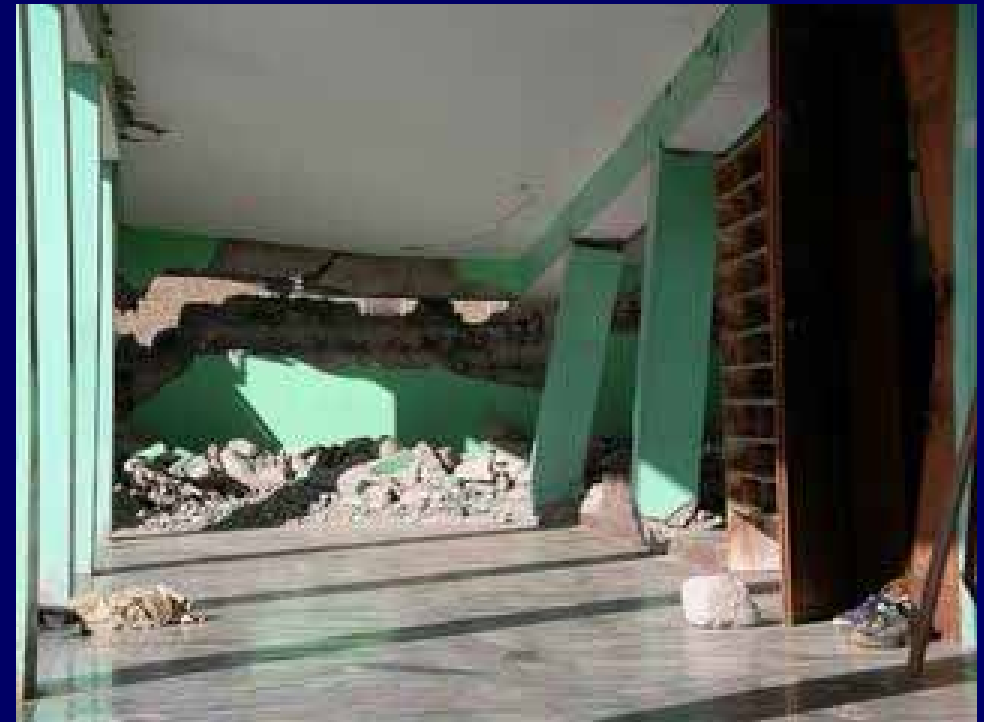
- ◆ Columns Seriously Damaged
- ◆ URM Walls Had Extensive Shear Cracks
- ◆ Seismic Capacity Evaluation: $C_B=0.14$
($C_B = \text{Strength} / \text{Building Weight} : \text{Base Shear Coef.}$)

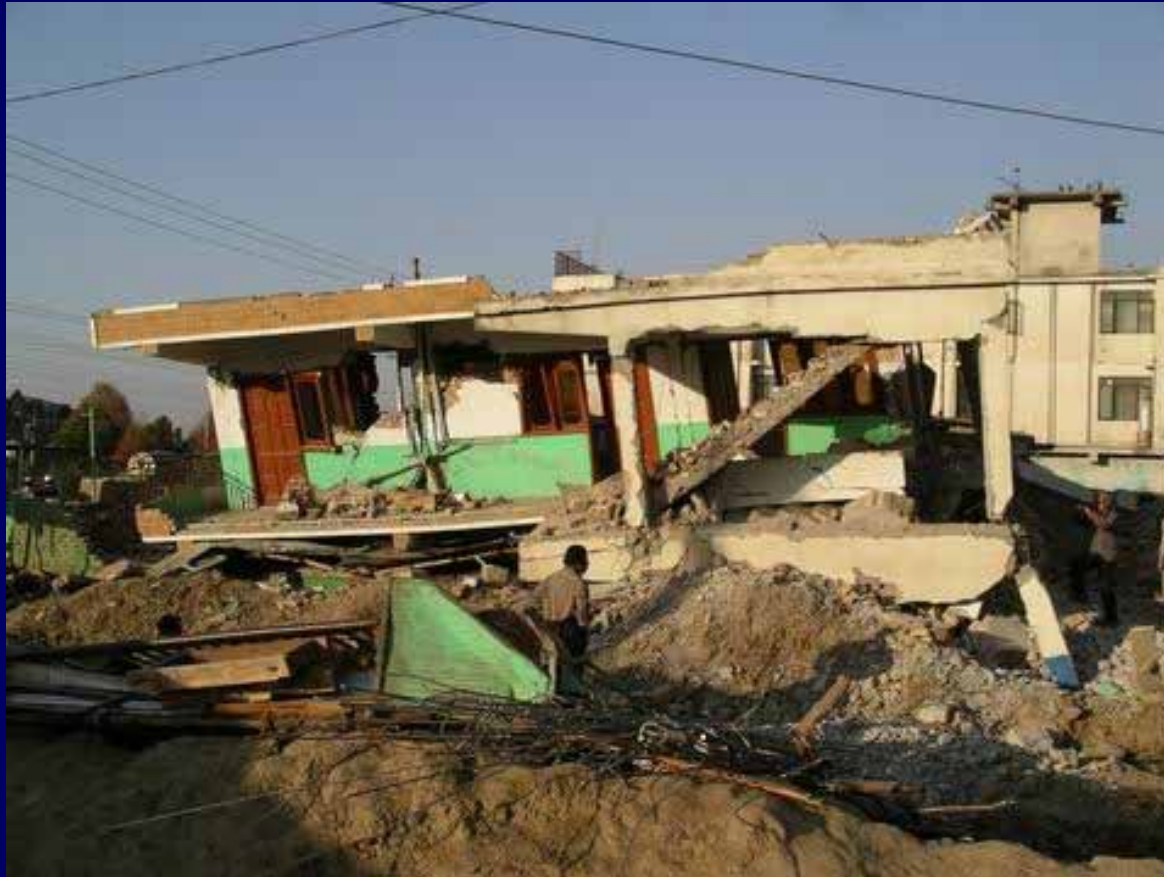
- ◆ Poor Shear Reinforcement in Members
- ◆ Poor Reinforcement Detailing in Beams

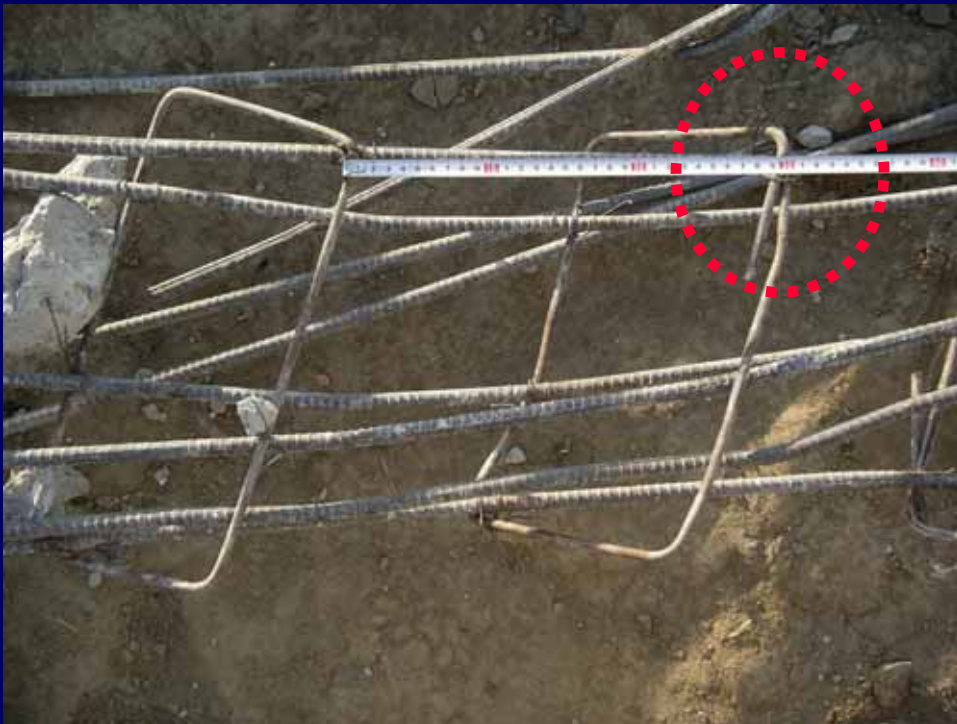
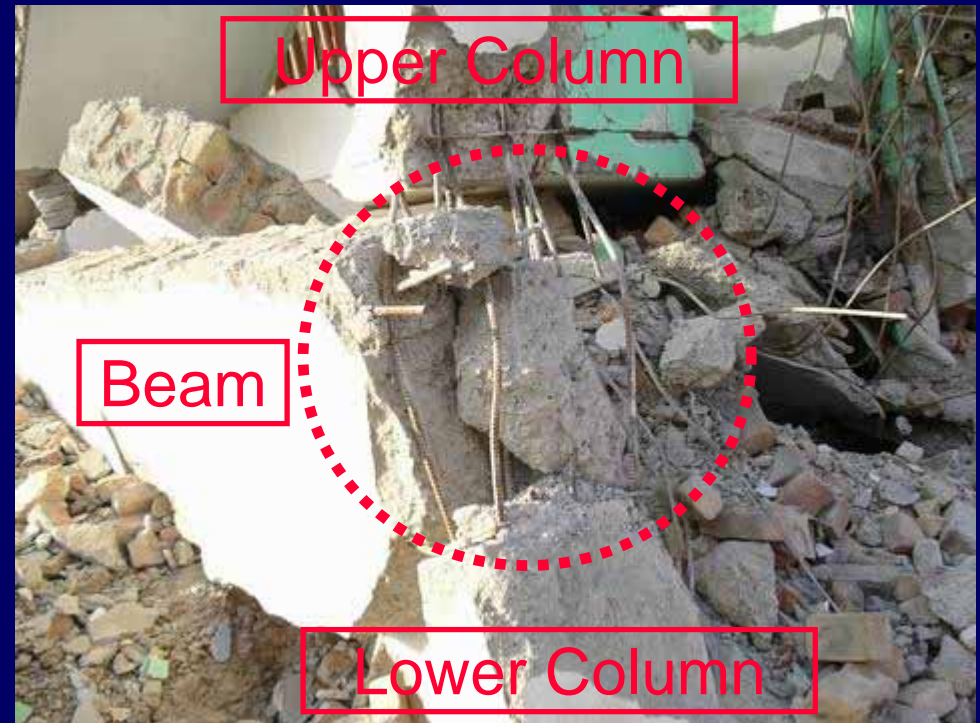
- ◆ Poor Shear Reinforcement in Members
 - Small diameter (6mm to 8mm) and wide space (30cm)
 - 90-degree hooks
 - No shear reinforcement in beam-column joints
