Damage Observations and Issues Related to Building Performance

Building Survey Team of
JSCE-AIJ Joint Reconnaissance Team

QUICK REPORT OF
DAMAGE INVESTIGATION ON BUILDINGS AND HOUSES
DUE TO OCTOBER 8, 2005 PAKISTAN EARTHQUAKE

November 26, 2005

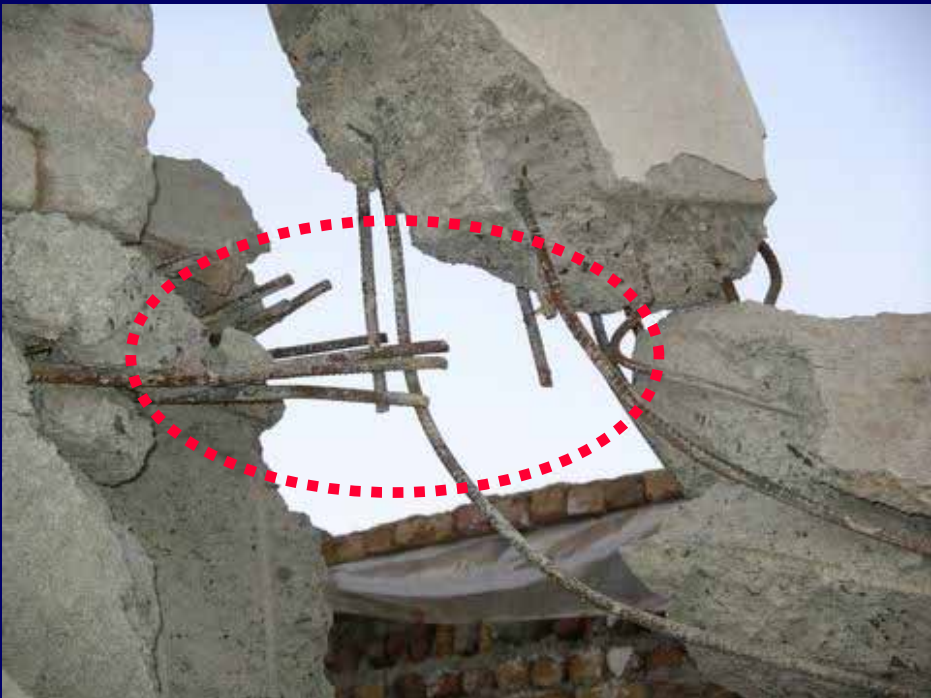
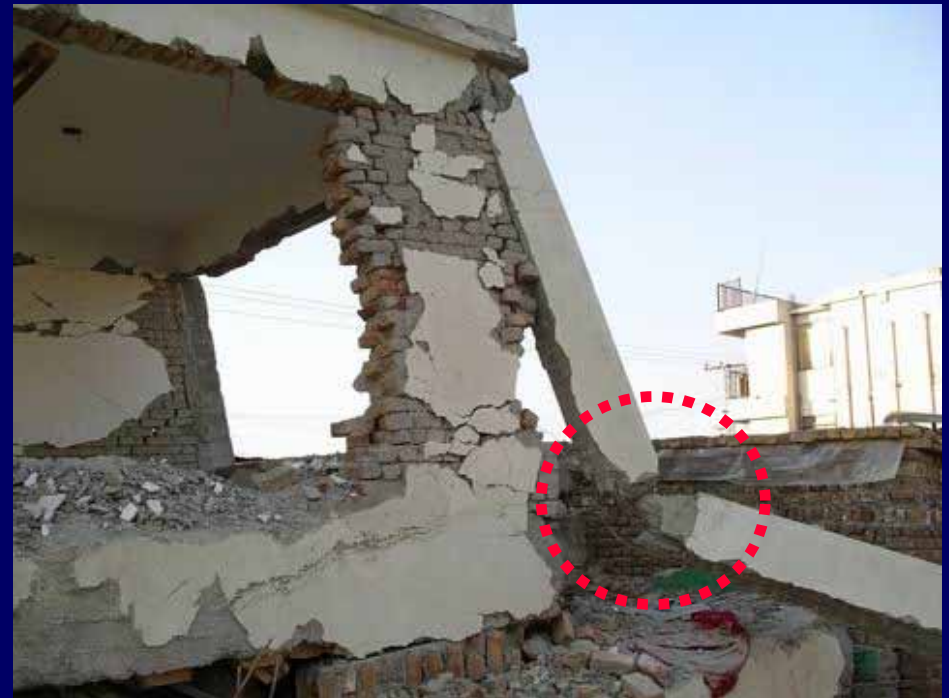
- ◆ Poor Reinforcement Detailing in Beams
 - Anchored straightly into beam-column joints
 - No bent into core concrete
 - ➔ Beam-column connection failure
 - ➔ Pin-connected frames rather than moment resisting frames

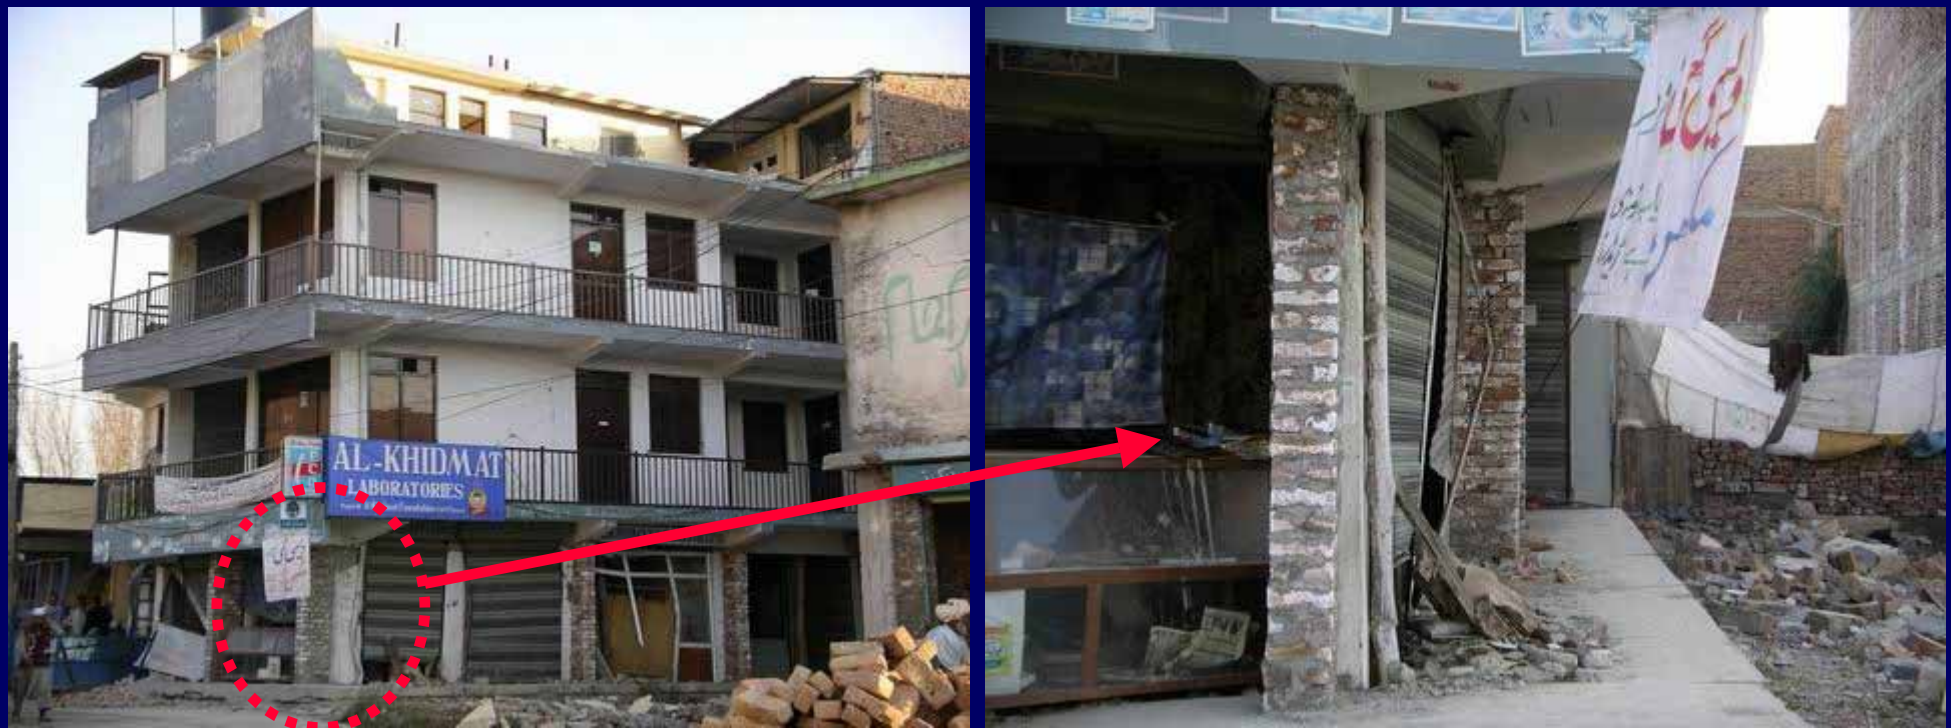
◆ Poorly Repaired Damaged Buildings

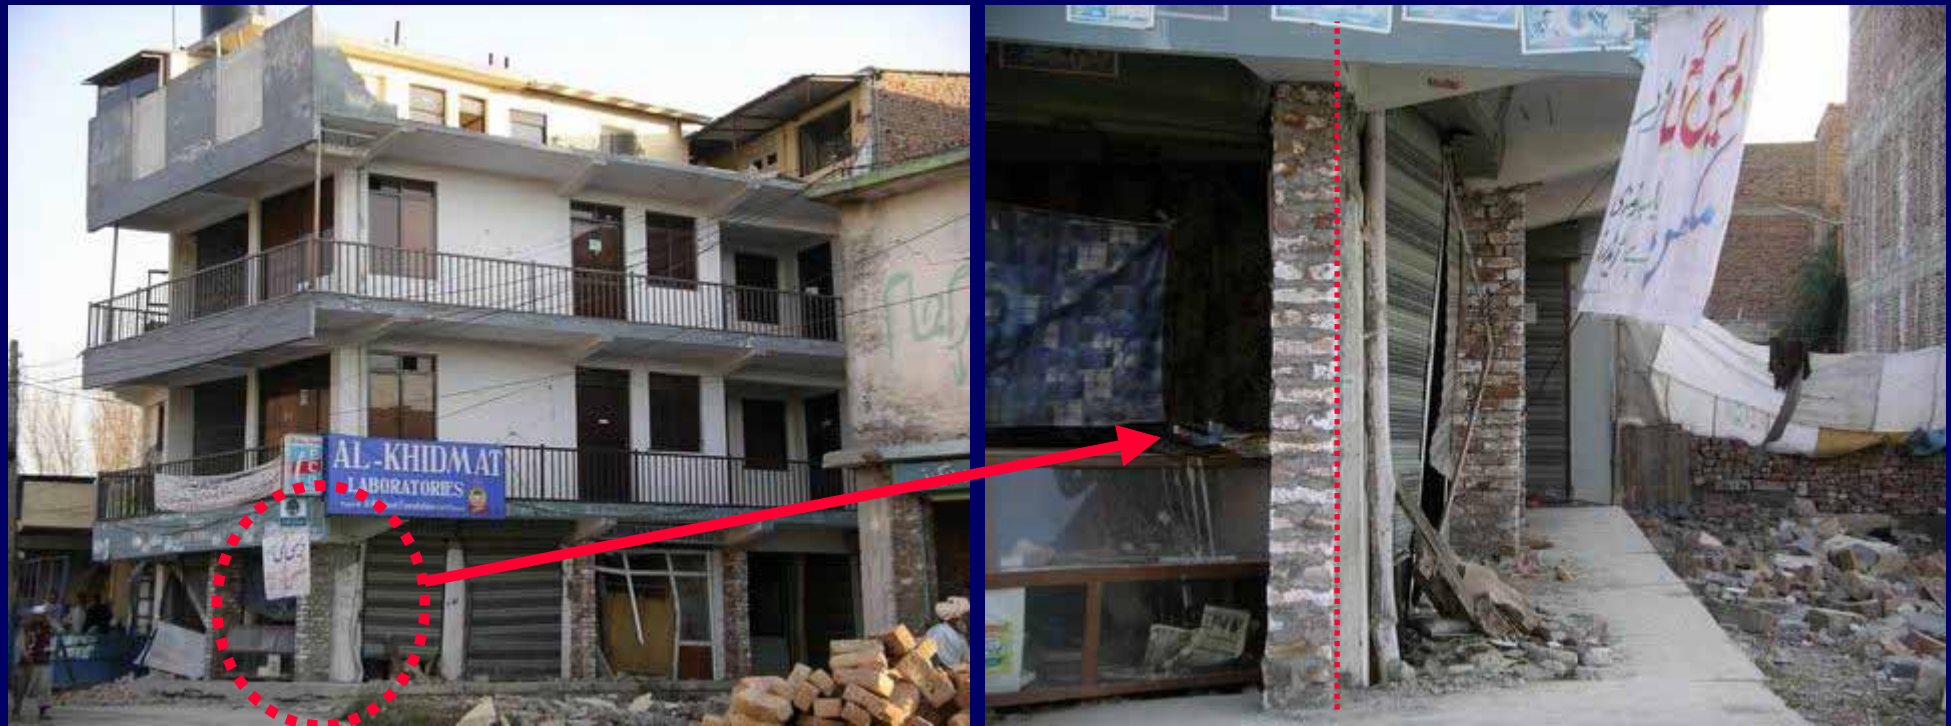
◆ Poorly Repaired Damaged Buildings

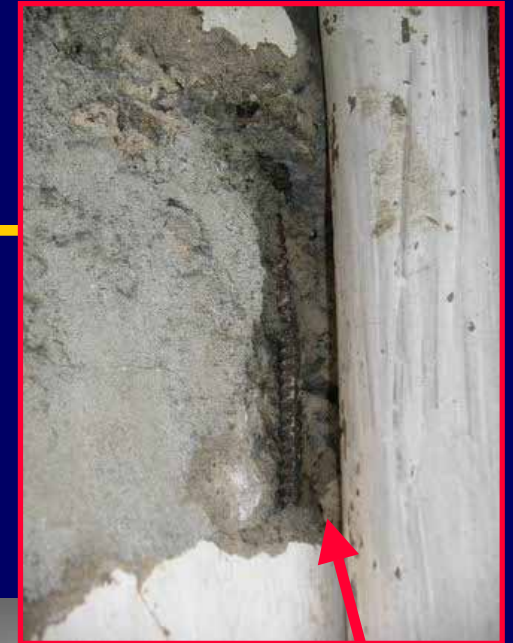
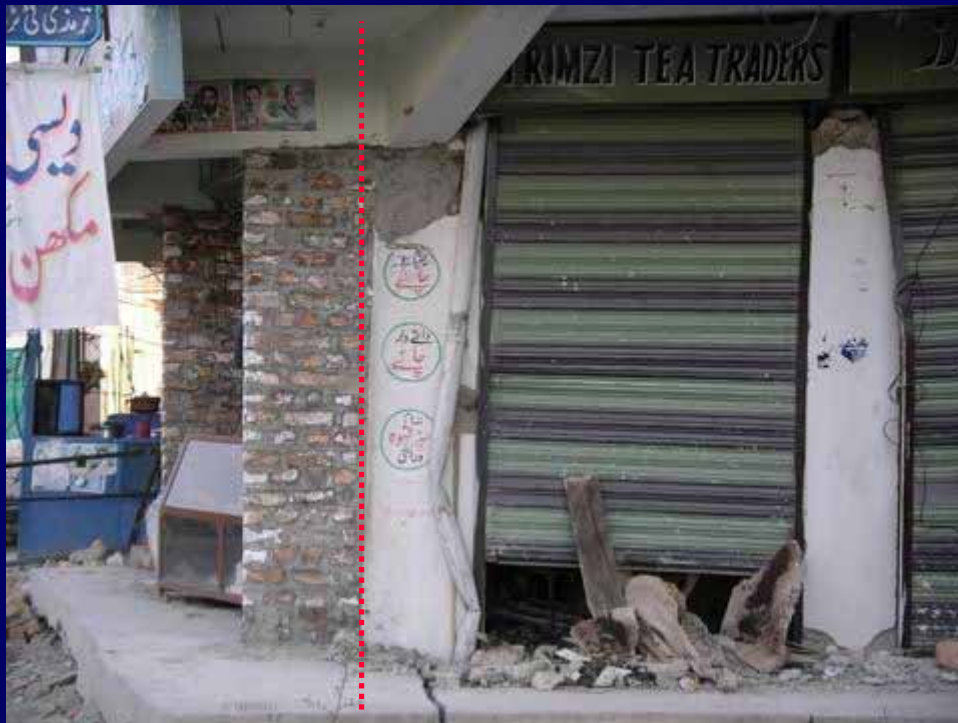
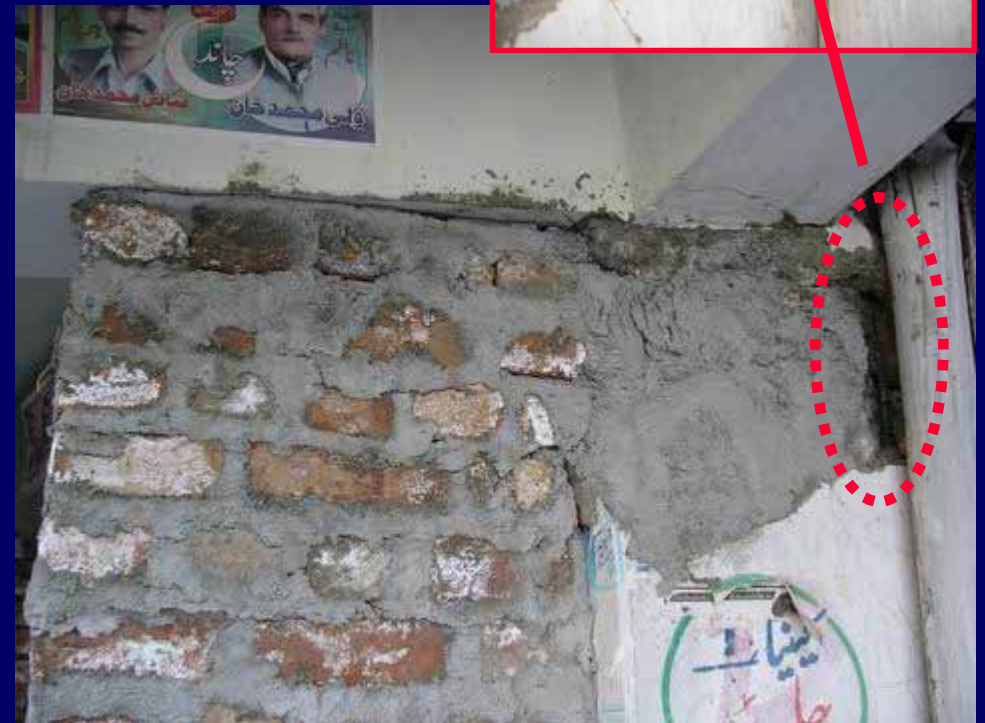
- ◆ Poorly Repaired Damaged Buildings
 - ➔ Technical guidelines for post-earthquake rehabilitation are most needed

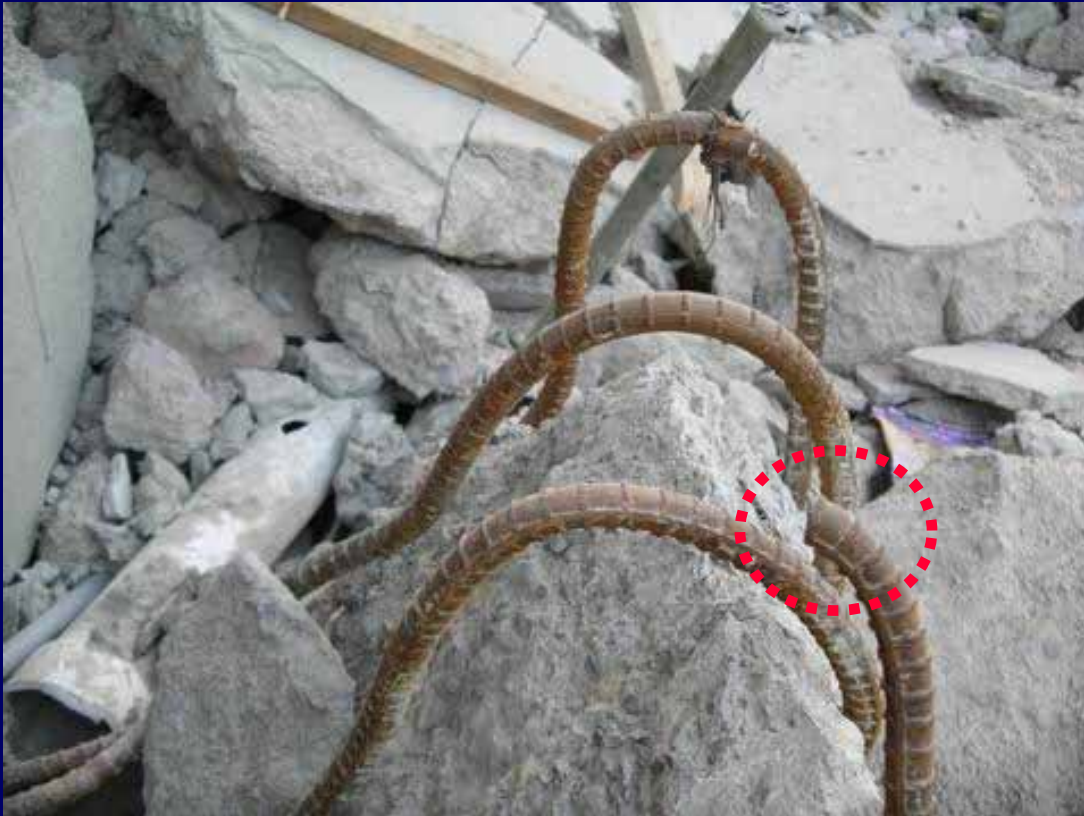
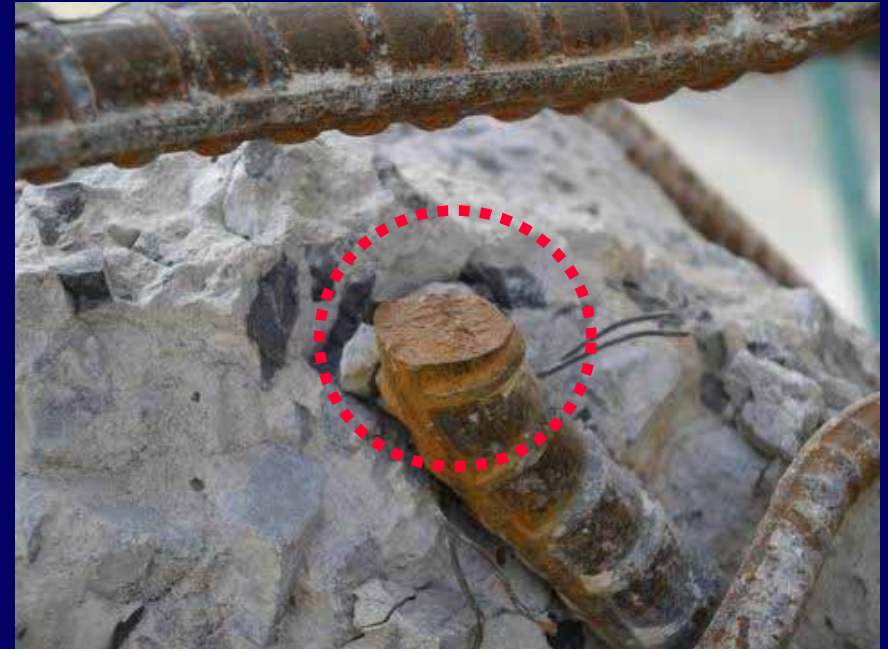
- ◆ Quality of Reinforcing Bars
 - Brittle failure without necking at fractured section
 - Also observed in other areas

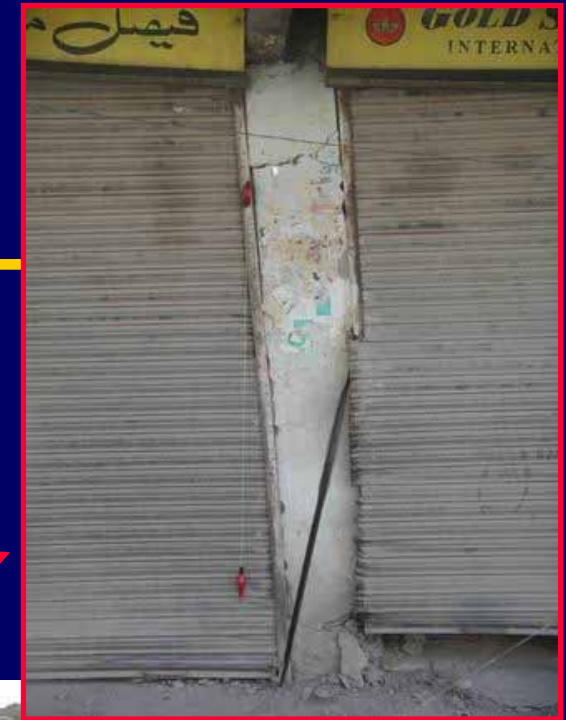
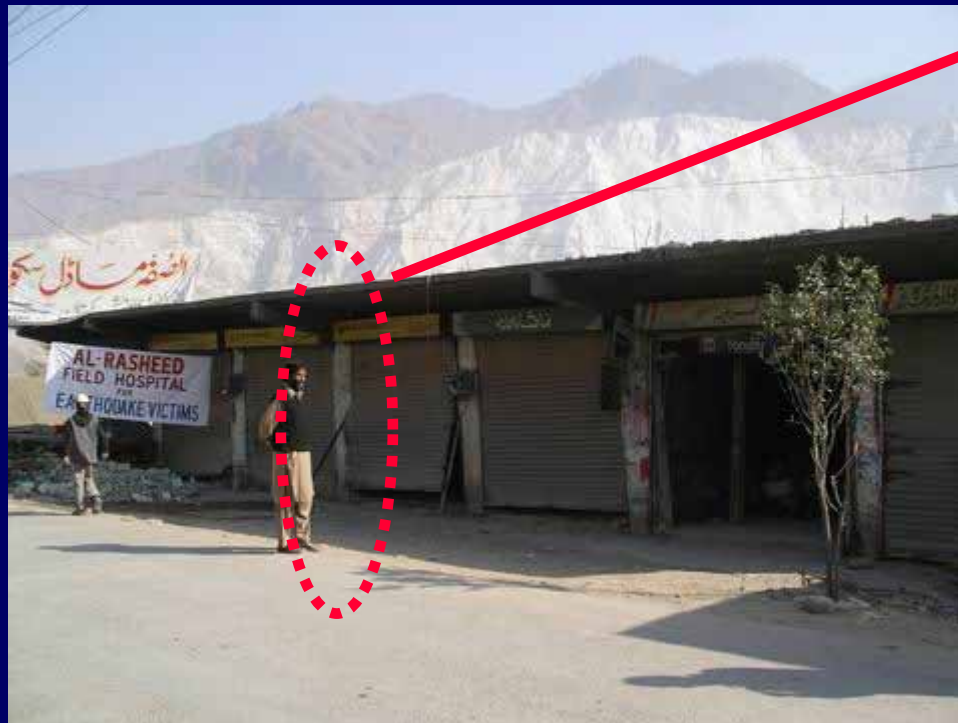
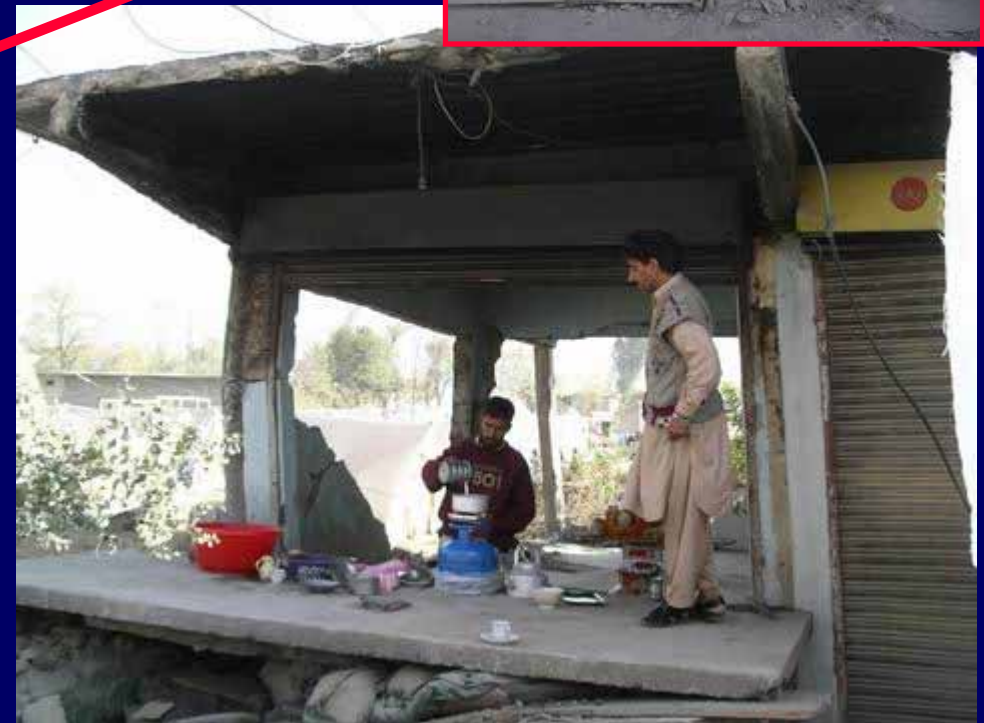
- ◆ Vulnerable Buildings in Use
- ➔ Quick inspection of damaged buildings needed

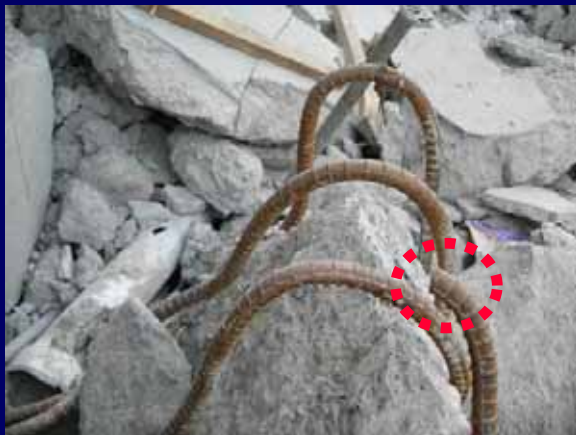
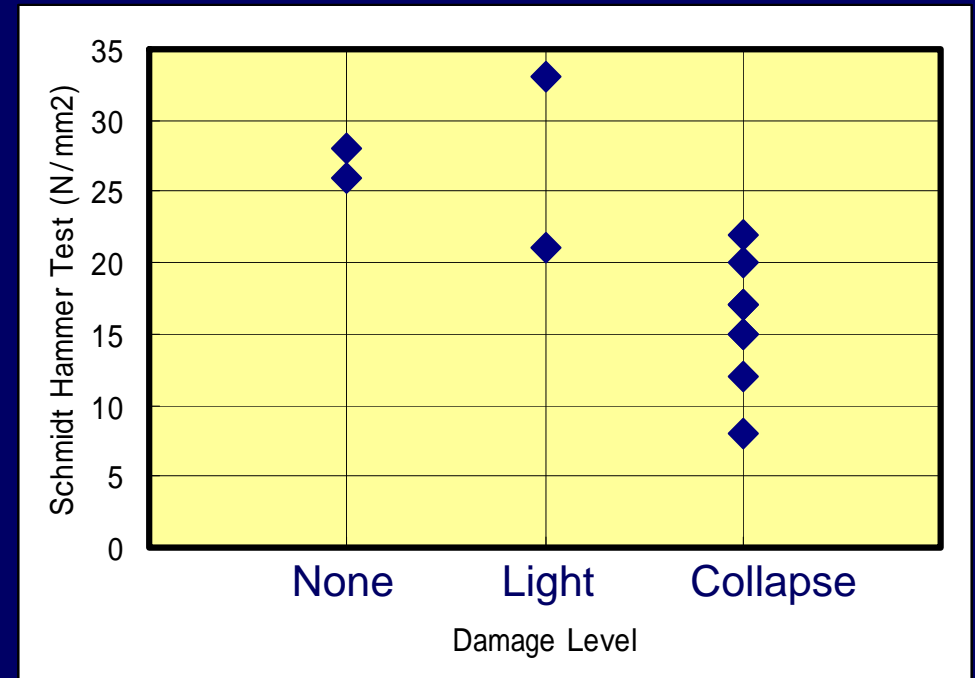
- ◆ Concrete Quality
 - No ready-mixed concrete
 - Honeycombs
 - Coarse/fine aggregate
 - Damage vs. strength
- ◆ Reinforcement Quality
 - Brittle failure

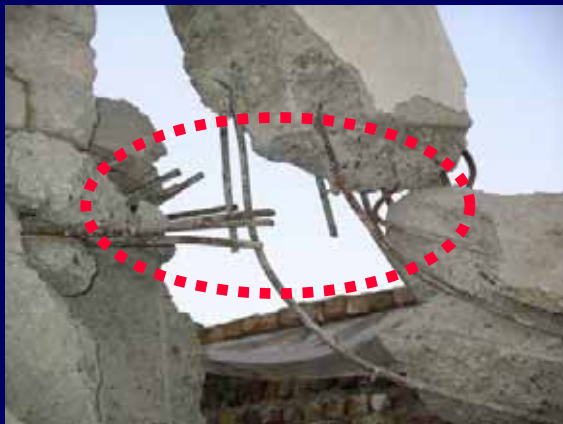
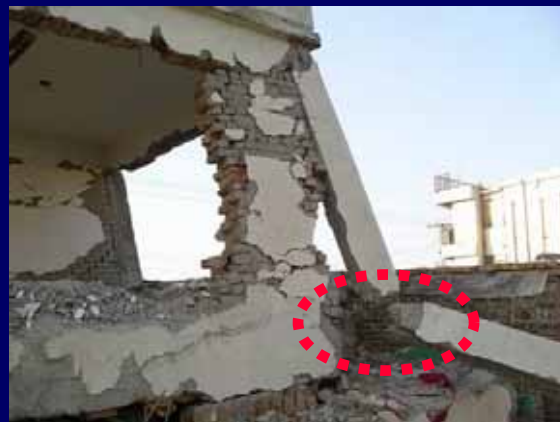
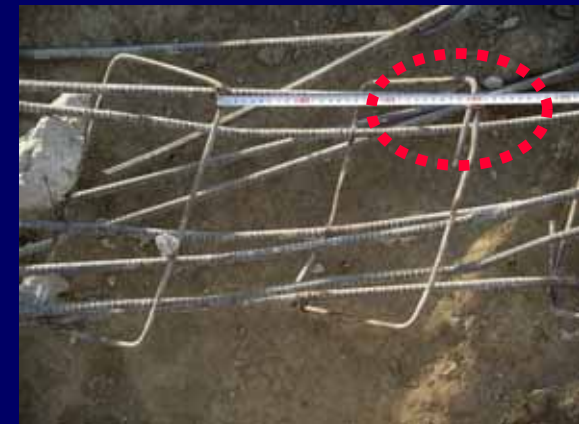
- ◆ Properly anchored beam rebar in joints to avoid
 - Easy pulled-out failure
 - Pin-connected frames (→ moment resisting frames)
- ◆ Shear Reinforcement and Concrete Confinement
 - Too small and widely spaced shear reinforcement
 - 90-degree hooks (→ 135-degree hooks)for poor ductility and axial load carrying capacity

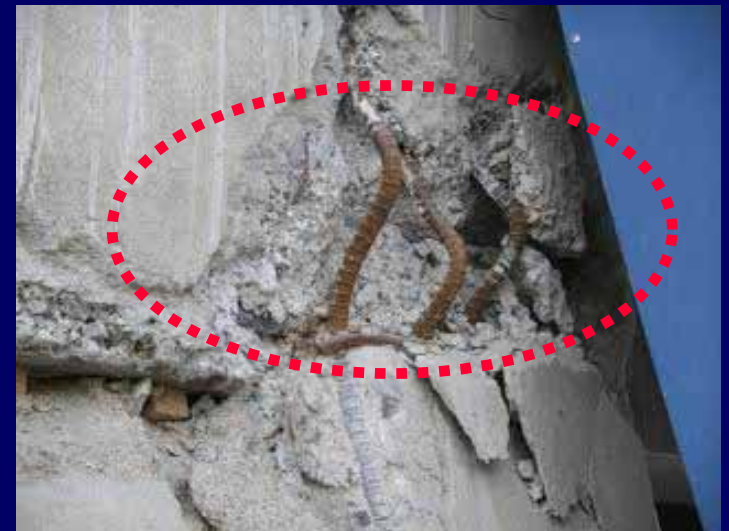
- ◆ Nonstructural Damage to URM (Unreinforced Masonry) Walls
 - Falling debris: hazardous to occupants
 - Lateral resistance and stiffness from RC and/or RM Walls
- ◆ Beam-Column Joints
 - No shear reinforcement in practice
 - Joint failure with buckling of rebars
