Damage Observations and Issues Related to Building Performance

Building Survey Team of
JSCE-AIJ Joint Reconnaissance Team

QUICK REPORT OF
DAMAGE INVESTIGATION ON BUILDINGS AND HOUSES
DUE TO OCTOBER 8, 2005 PAKISTAN EARTHQUAKE

November 26, 2005

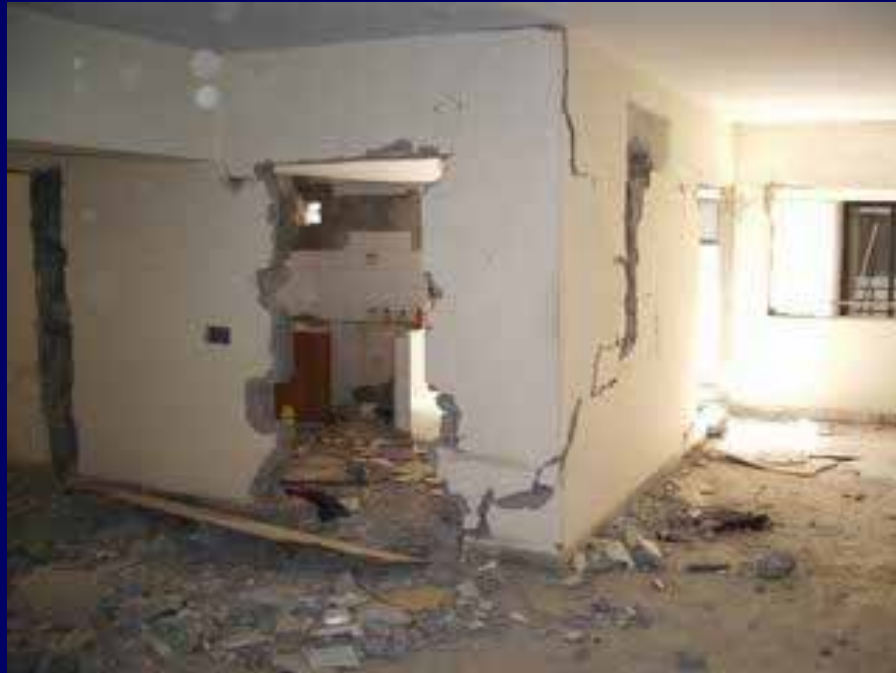
Islamabad Margala Towers

- ◆ Extensive Damage to URM Walls
- ◆ Damage to Expansion Joints
- ◆ However, No Major Damage to Structural Members

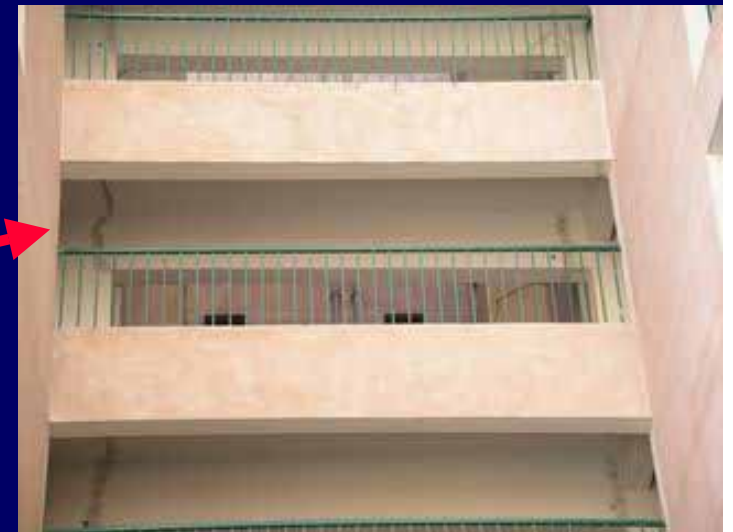
East Building

◆ Cracks in Beams of:

- Basement: Mid-span
- Open corridor in upper stories: Beam-ends → Caused by
